# A Validated Industrial Case Study Demonstrates a Practical Maintenance Intervention for Centrifugal Pump Mechanical Seals Under Supply-Chain Constraints

Dangote Fertiliser Limited

The study focuses on UF Backwash Pump 50-P-007B, part of a two-working, one-standby arrangement for ultrafiltration permeate backwash. The pump is a horizontal centrifugal design with an axially split casing, rated at approximately 1100 m<sup>3</sup>/h at 50 m total differential head (TDH), operating at 1488 rpm and driven by a 250 kW ABB motor with variable-frequency drive (VFD) control. The pumped fluid is UF permeate with a density near 1000 kg/m<sup>3</sup> and typical operating temperatures ranging from 22 to 34 °C (design temperature up to 65 °C). Key parameters are summarized in Table 1.

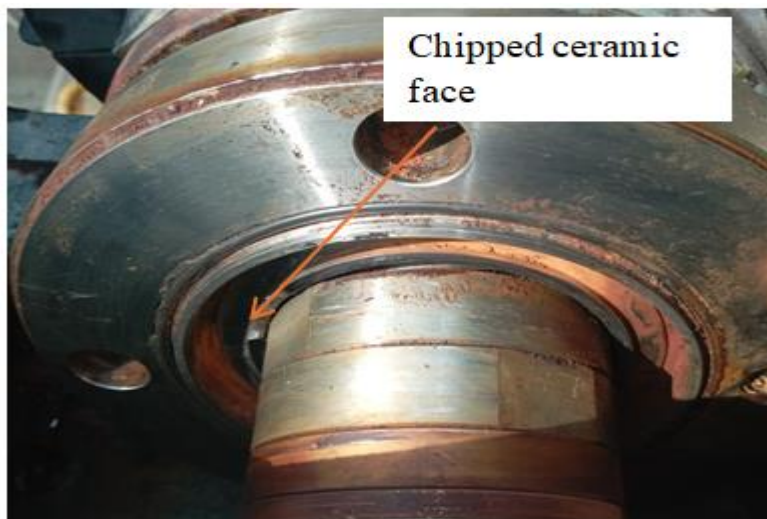
Fig 2. Inspection of the chipped ceramic face

During routine operation, leakage was observed at the seal gland region of Pump 50-P-007B, prompting controlled shutdown and dismantling. As shown in Fig. 1, Inspection revealed localized chipping of the stationary ceramic seal face, consistent with surface degradation and loss of effective sealing contact. The

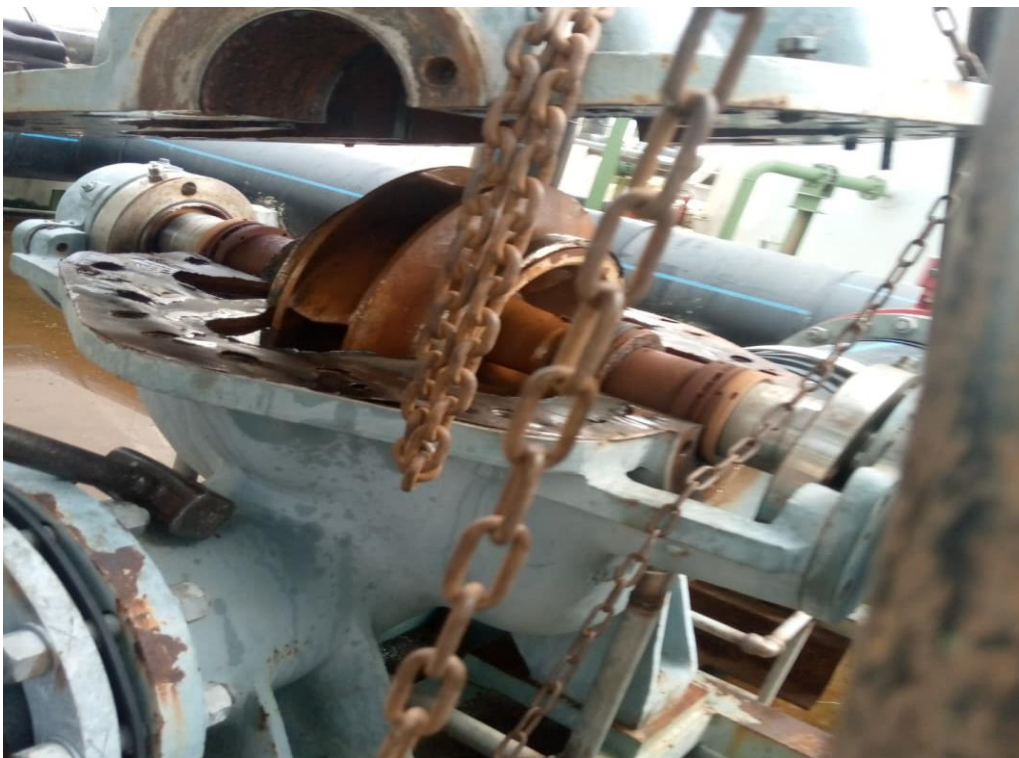
Fig 3. Unboxing 50-P-007B top case cover

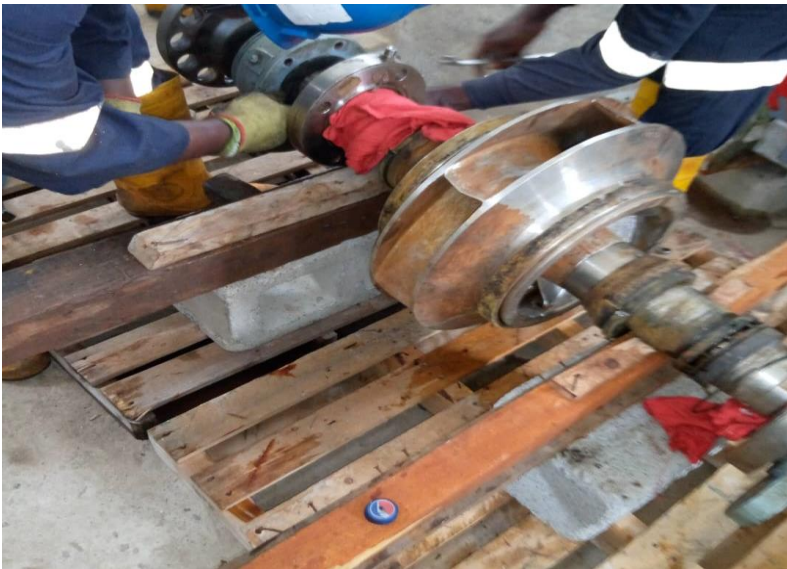
Fig 4. 50-P-007B bearings/ seal removal

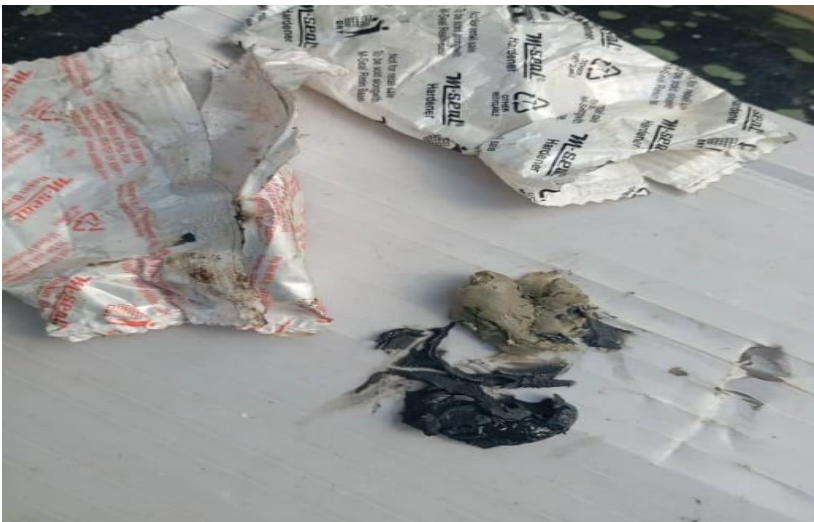
Fig 5. Epoxy composite material

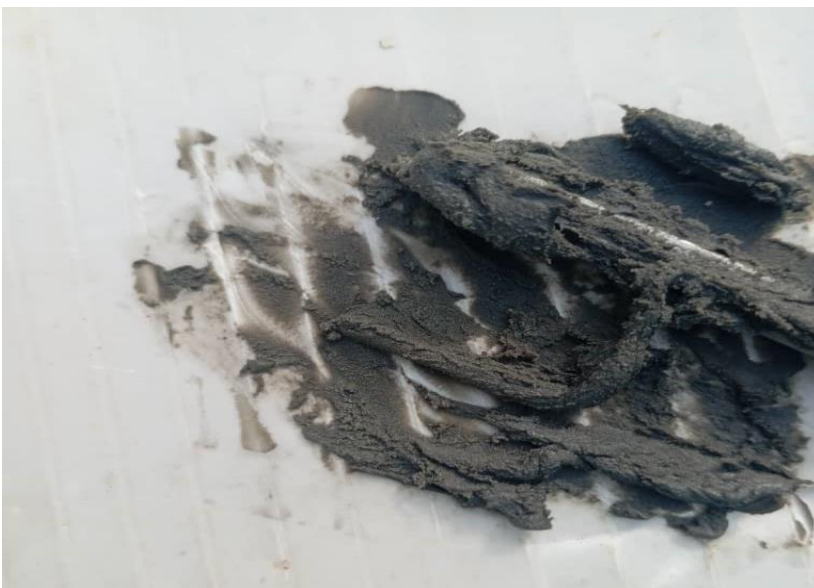
Fig 6. Mixing of epoxy composite material

4. **Epoxy Application:** M-Seal epoxy was mixed following the manufacturer's instructions and applied in thin, controlled layers to fully rebuild the chipped area. Air entrapment was minimized, and the surface was slightly overbuilt to allow subsequent finishing.

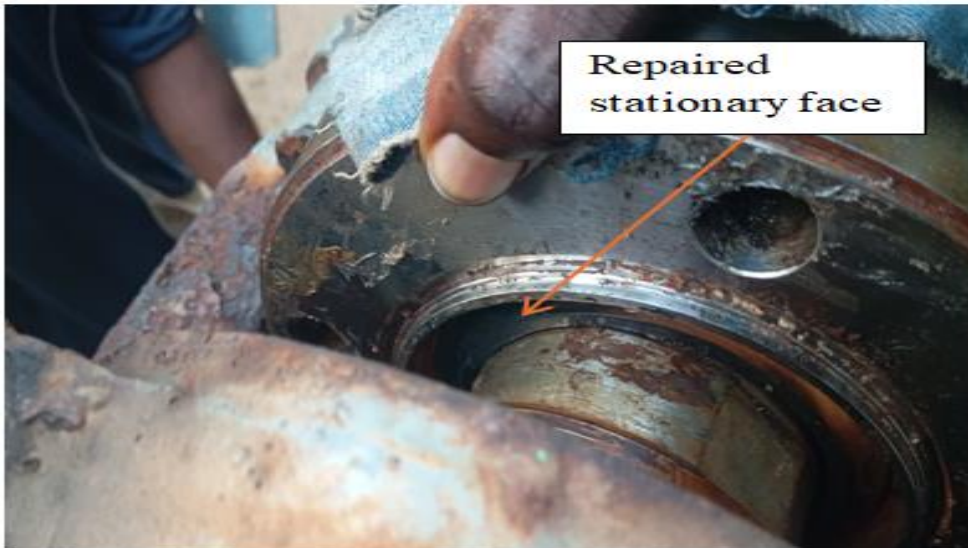
Fig 7. Repaired the stationary mechanical seal face

5. **Curing:** The restored seal face was allowed to cure under ambient conditions for a controlled period of 24 hours. The assembly was protected from vibration or disturbance during curing to prevent surface waviness or adhesion compromise.

6. **Finishing and Lapping:** After curing, the repaired surface was finished using fine abrasives and lapping to restore flatness and ensure a smooth sealing interface compatible with the rotating mating ring. Flatness was verified with a straightedge and feeler gauge.

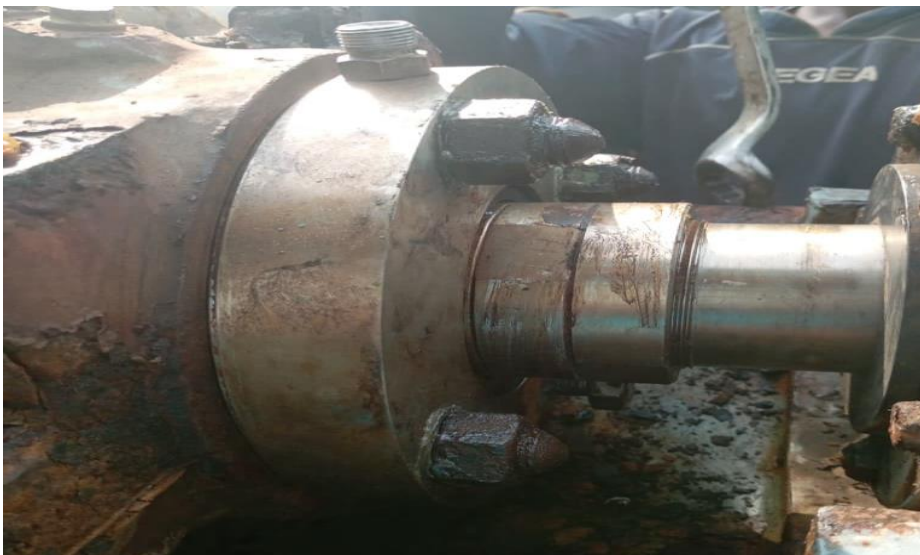
Fig 8. Boxing up of the mechanical seal face

7. **Reassembly and Verification:** The mechanical seal was reinstalled in the pump, ensuring correct alignment. The flush line and seal gland were inspected for cleanliness before starting up.
