# Forensic Evaluation and Condition-Based Rehabilitation of A High-Rainfall Mountain Highway: Samdrup Jongkhar–Trashigang Road, Bhutan

Deepak Baskandi

Border Roads Organisation

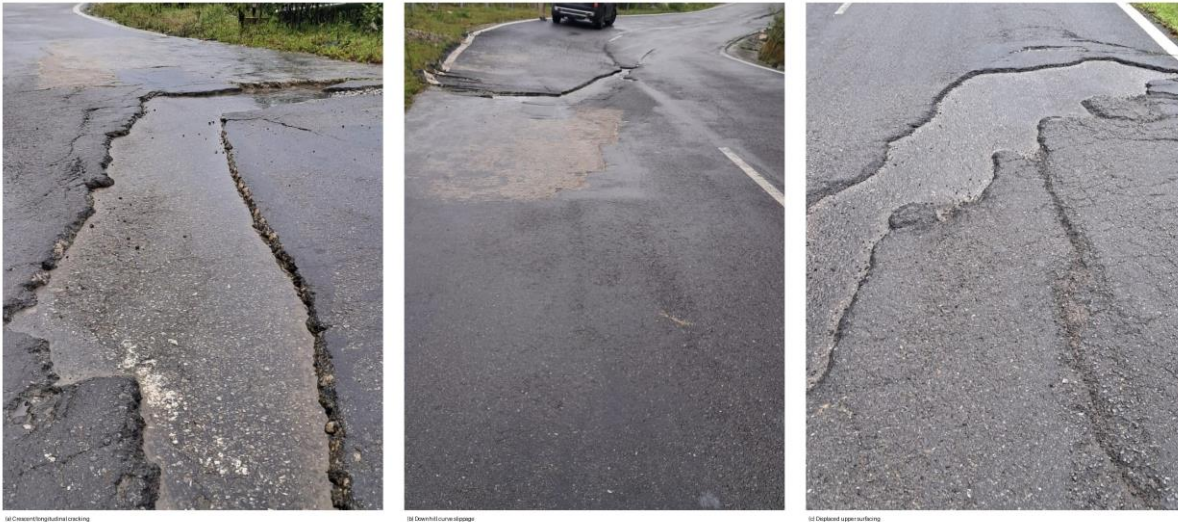
The upper corridor (Km 40-72.8) contains crescent-shaped and longitudinal cracking, local displacement of the wearing course, and repeated shoving in the loaded downhill lane. The morphology is compatible with an interlayer shear mechanism: horizontal traffic demand exceeds the available bond or shear resistance, allowing the upper course to translate relative to the layer below. However, surface appearance cannot establish the depth of the failed plane. Similar-looking distress can arise from interface delamination or instability within the asphalt mixture itself; systematic coring and bond/shear testing are therefore required (Doyle et al. 2022).

Fig. 1. Representative slippage/shoving distress in the loaded downhill lane, Km 40-72.8.

For localized slippage, milling or saw-cutting should extend beyond visible distress until sound, stable material is exposed. The lower layer should be examined for stripping, deformation, trapped moisture, and delamination. Only after the substrate is dry or appropriately conditioned and free of loose material should tack coat be uniformly applied with a calibrated distributor. Dense BC is suitable where the defect is shallow; DBM + BC is required where removal extends deeper or structural design indicates strengthening. A routine seal coat over dense BC is not inherently required. Traffic opening should follow cooling, joint finishing, and acceptance checks.

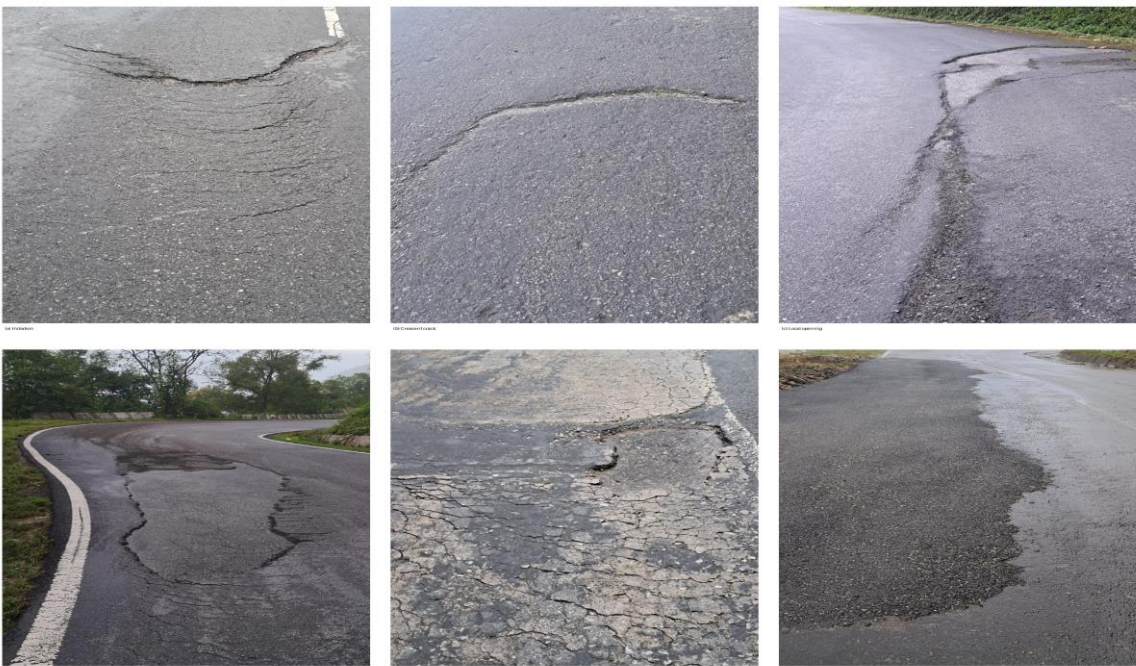
Fig. 2. Field-observed progression from crack initiation to advanced slippage and patch repair.

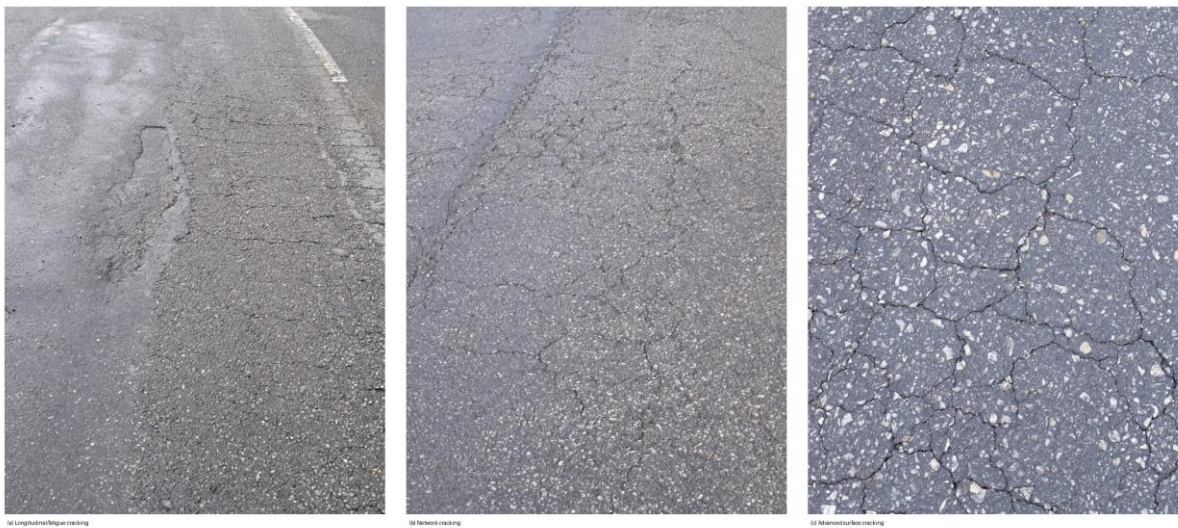
The lower corridor (Km 5-40) exhibits a different distress family. Network cracking, longitudinal/fatigue-type cracking, potholes, and isolated curve-related slippage are more prevalent. The difference in distress morphology, pavement age, and intervention history supports treating the two zones as separate forensic populations. A single corridor-wide resurfacing prescription would obscure the distinction between a predominantly condition/structural problem in the lower corridor and an interface/shear problem in the upper corridor.

Fig. 3. Representative cracking distress in Km 5-40.
