Post-Foundation Studies Using Integrated Geophysical and Geotechnical Methods at New Agbor Road, Uromi, Edo State, Nigeria

Abstract: Globally, the incessant failure of buildings has drastically led to an increase in the loss of lives and properties, posing lots of concerns about the causes of these devastating effects. This research evaluates the immediate and remote causes of probable foundation failure on some buildings at Ohunyon Street, Uromi, Edo State, using integrated geophysical and geotechnical methods. By optimizing the measured field, calculating the apparent resistivity data, and interpreting the generated electrical resistivity tomography by using the SAS 1000 terrameter and RES2DINV software, a variation in soil resistivity and type was established. The geotechnical method required performing Atterberg limit-index studies on the gathered soil specimens in the region as well as geological laboratory grain size analyses. The pole-dipole results showed two weak zones and one moderately competent zone, whereas the dipole-dipole results revealed three primary layers: topsoil (sandy clay), clayey loam, and silty loam. The results also revealed regular clay permeation withi

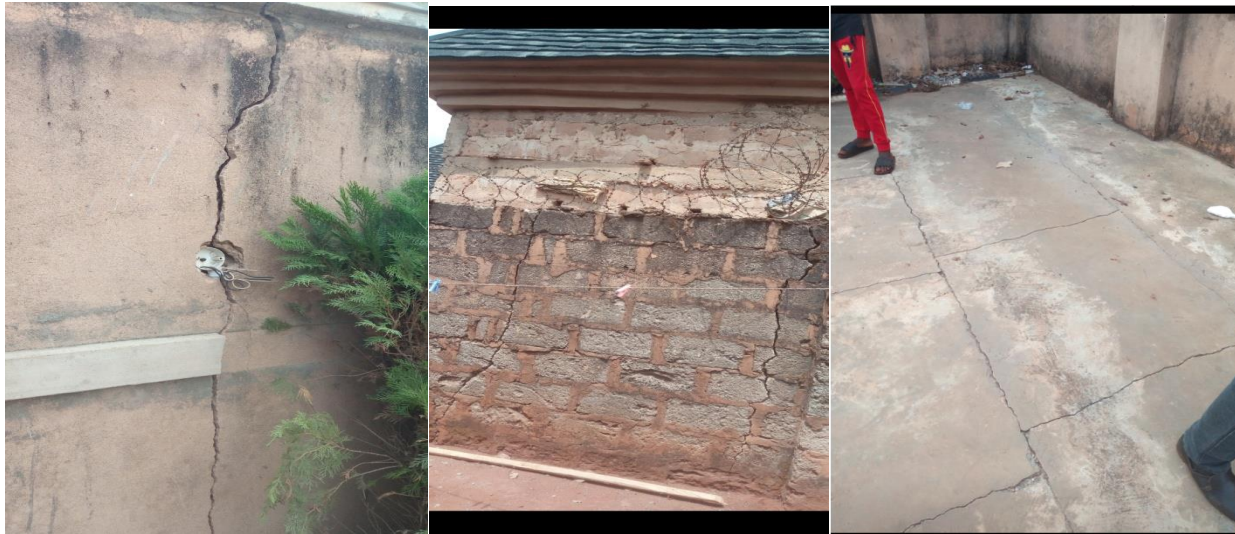
Probable signs of structural failure (cracks) were observed on the walls, compound floor, and fence of a building (figure 1a) at Ohuyun Street in Uromi, Edo State, Nigeria, immediately after its construction. Further examining the building and its environs in order to ascertain the level of damage, it was observed that the failure was not only peculiar to the said building but also to a nearby building (figure 1b) and some others within the neighborhood. The fundamental purpose of this paper is to use 2-Dimensional Electrical Resistivity Tomography and Geotechnical techniques in investigating the foundation failure of the buildings at Ohuyun Street in Uromi, New Agbor Road Esan North-East Local Government Area, Edo State, Nigeria, specifically to obtain the 2-D ERT data, the topographic land form, and the water content of the soil by quickly and thoroughly surveying the physical properties of the near-surface geologic structures, underground strata, and the load bearing capacity, in order to identify the possible causes of the failure, establish their resolutions, and aid in future prevention.

Figure 1a. Cracks on the main building of interest at the study location.

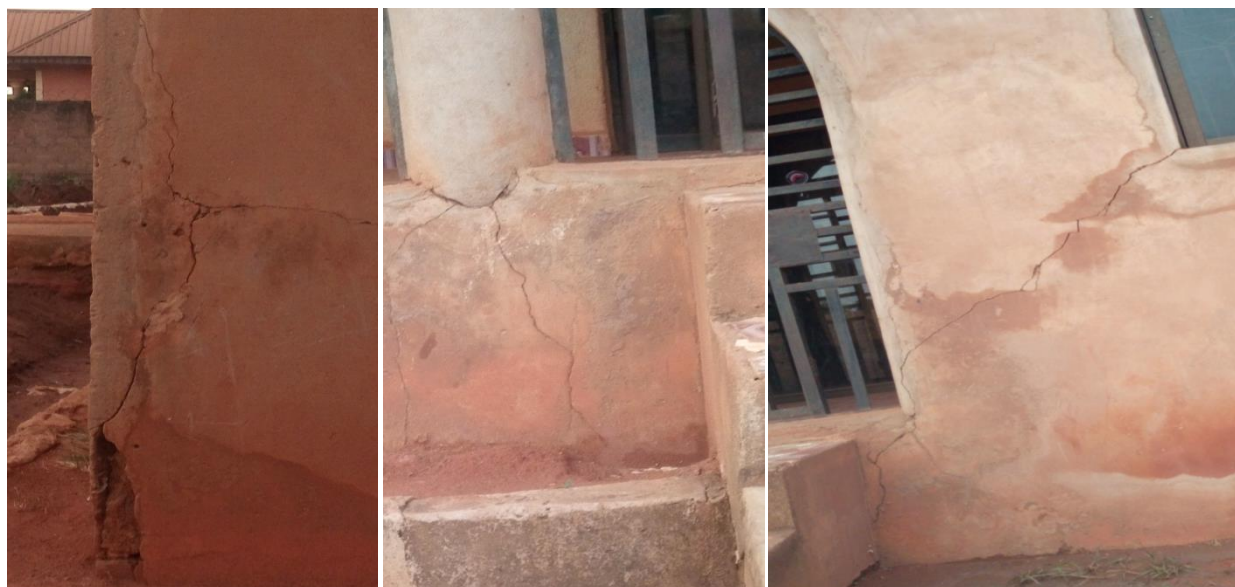
Figure 1b. Signs (cracks) of foundation failure observed on a nearby building.

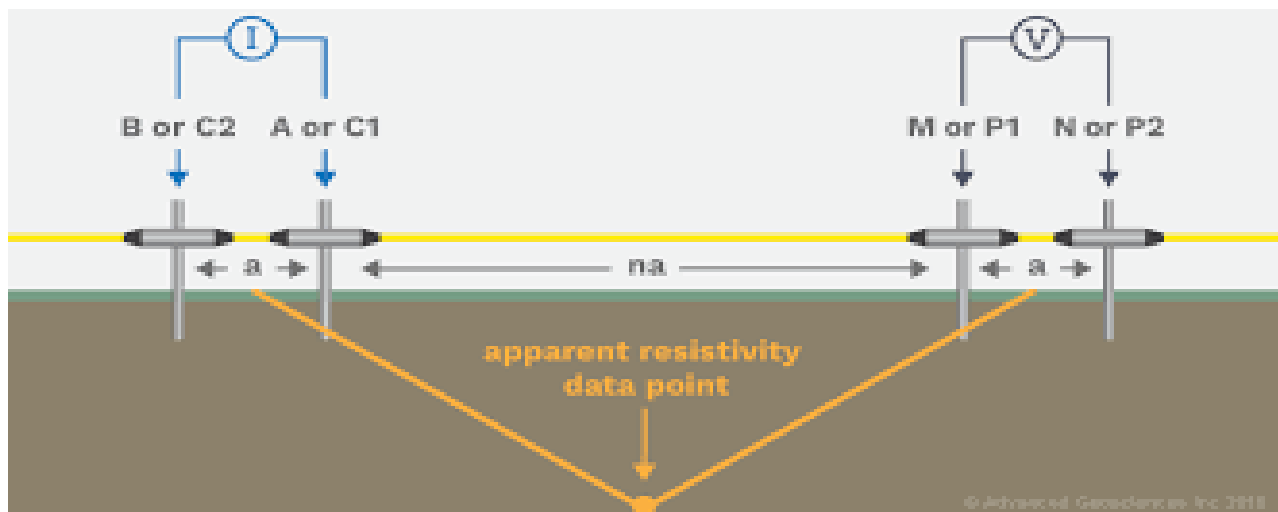
Figure 4a. Dipole-dipole array for data acquisition (Loke, 2004).

The resistivity measurements were made by injecting current into the ground through two transmitting current electrodes A and B (C_1 and C_2) and measuring the resulting voltage difference at another two receiving potential electrodes M and N (P_1 and P_2), (Figures 4a and 4b).

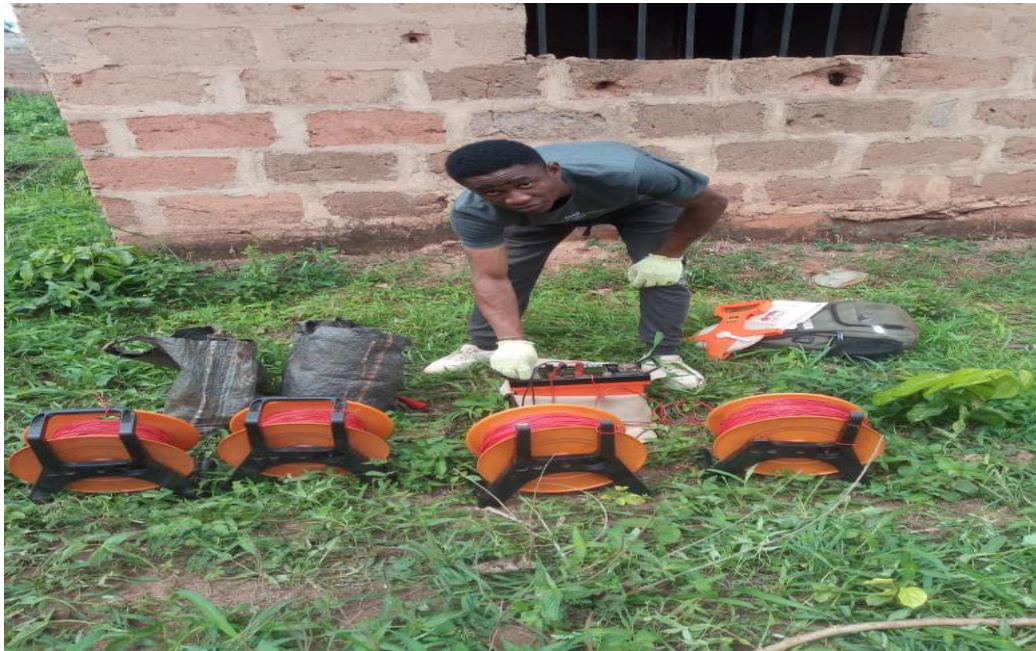
Figure 5. Instrument arrangement for the field data acquisition
