# The Implications of Geotechnical Properties of Soil in the Development of Gully Erosion in Ukpor, Southeastern Nigeria

Gully erosion is a devastating form of soil degradation threatening environmental sustainability, socio-economic development, and human well-being worldwide. The Southeastern region of Nigeria, particularly Ukpor, is prone to gully erosion, which has resulted in the loss of infrastructure, agricultural land, and human settlements. While various factors contribute to gully erosion, the soil's geotechnical properties remain an important aspect that has been given limited attention. This study investigates the implications of geotechnical properties of soils in the development of gully erosion in Ukpor. A comprehensive approach was adopted, combining drone-aided geologic field mapping, laboratory tests and spatial analysis. Soil samples were collected from different locations at 0.5 - 1m depth, and laboratory tests (Particle Size Distribution (PSD) and Atterberg Limits) were conducted to determine the soil's geotechnical properties. The results reveal that the study area is underlain by the Ogwashi-Asaba formation. From the Particle Size Distribution and Atterberg

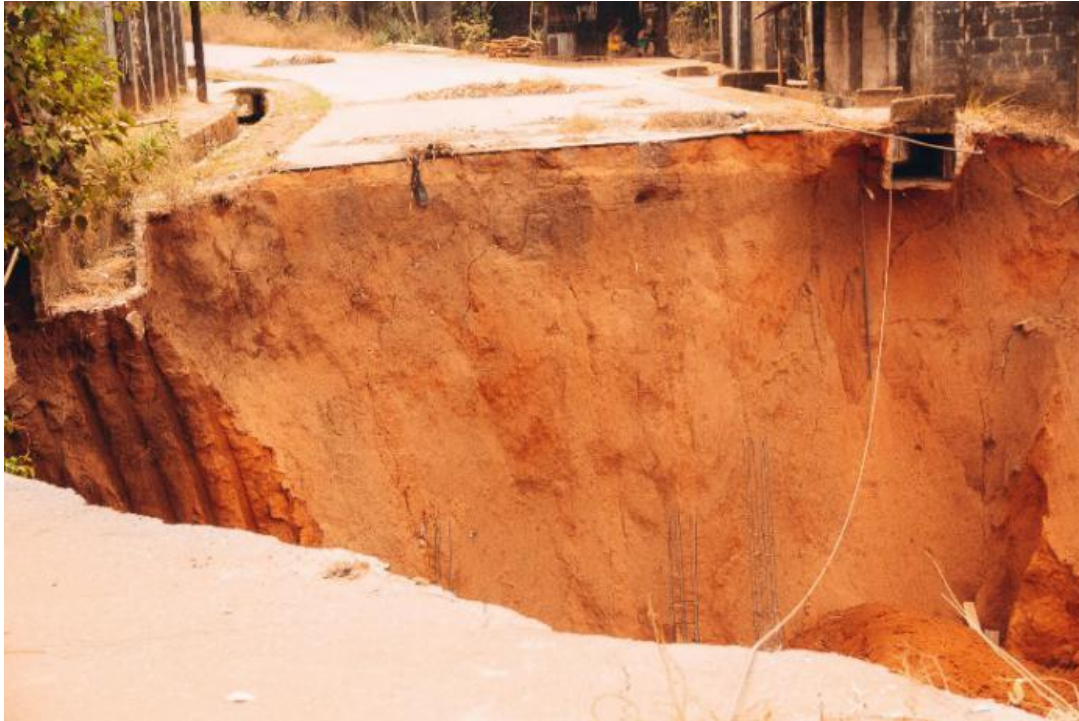
Fig. 3: Gully erosion site at Ezinifite Road, Ebenator

Fieldwork was carried out to examine six active gully sites, (Fig. 3, 4, 5, 6, 7 and 8), measure their magnitude by taking measurements of depth, length and width, and assess the impact of the gullies on the socio-economic wellbeing of the people in the study area; identify causative factors as well as appraise the effects of control measures already in place. Where no control measures are in place, appropriate ways of checkmating the menace are suggested.

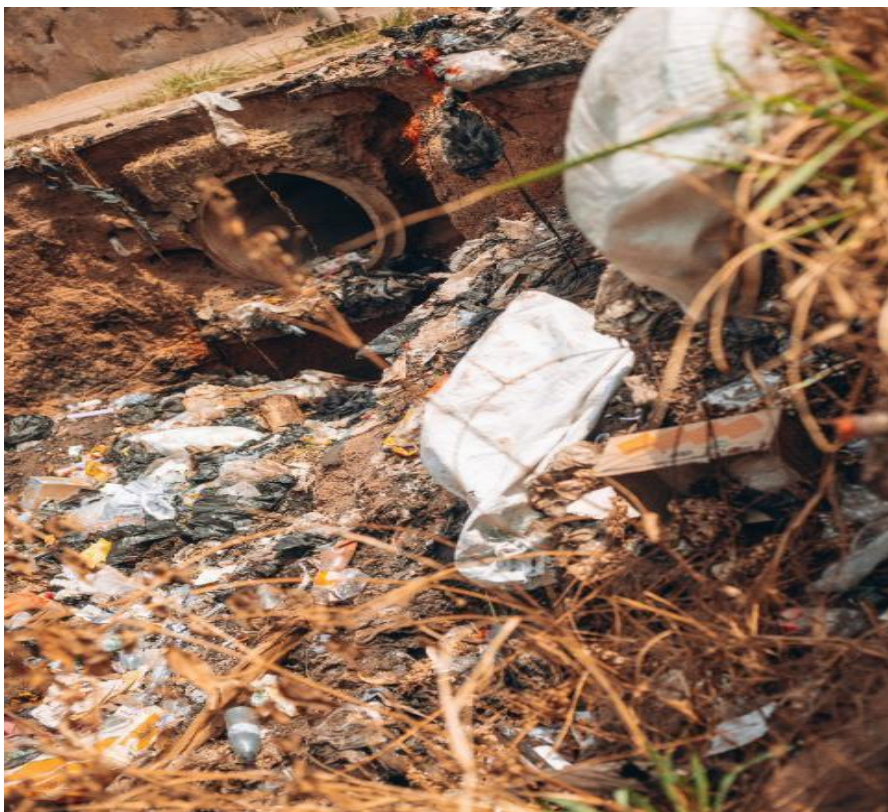
Fig. 4: Gully site at Umudim-Nnewi

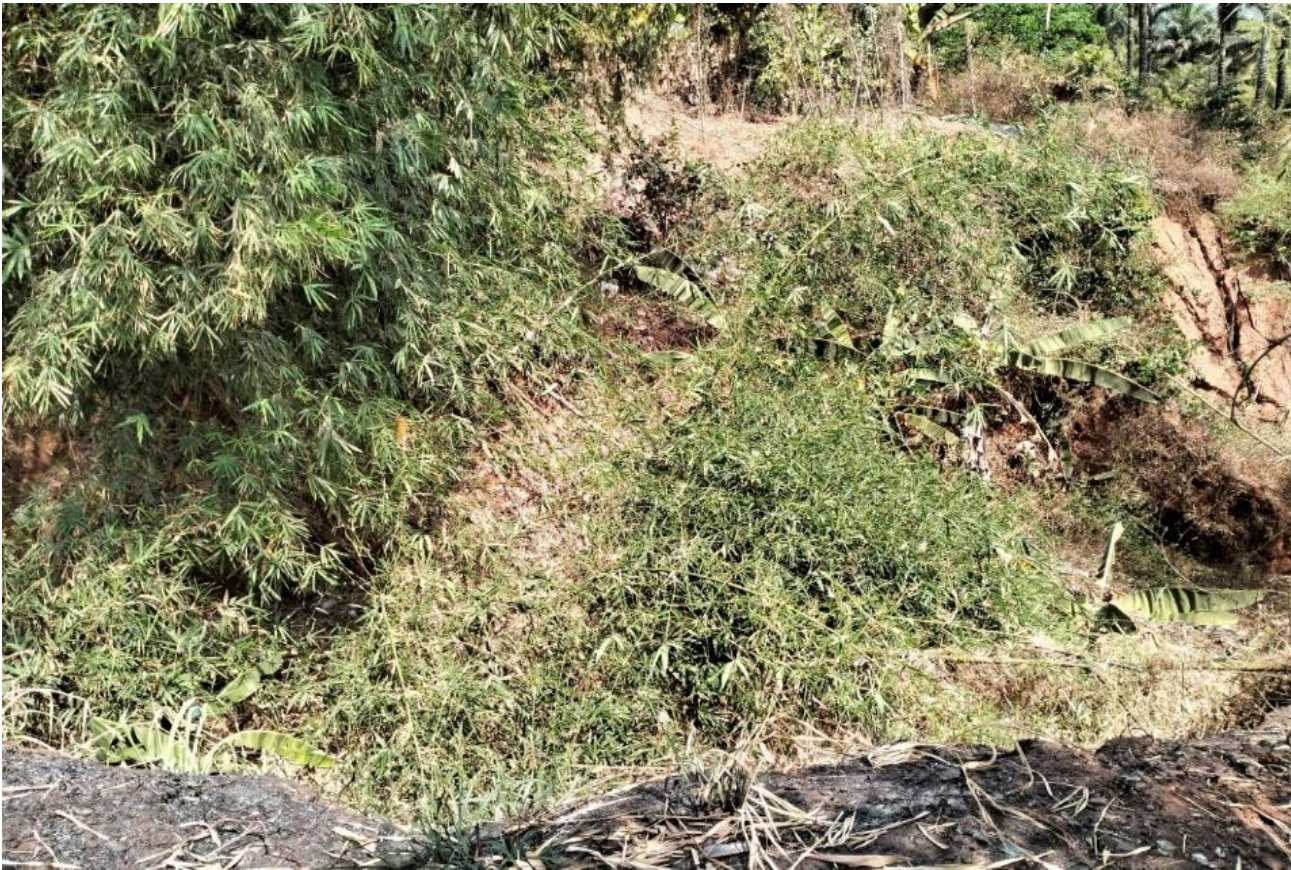
Fig. 5: Gully exposure at Nnewi South Local Government Headquarters, Ukor

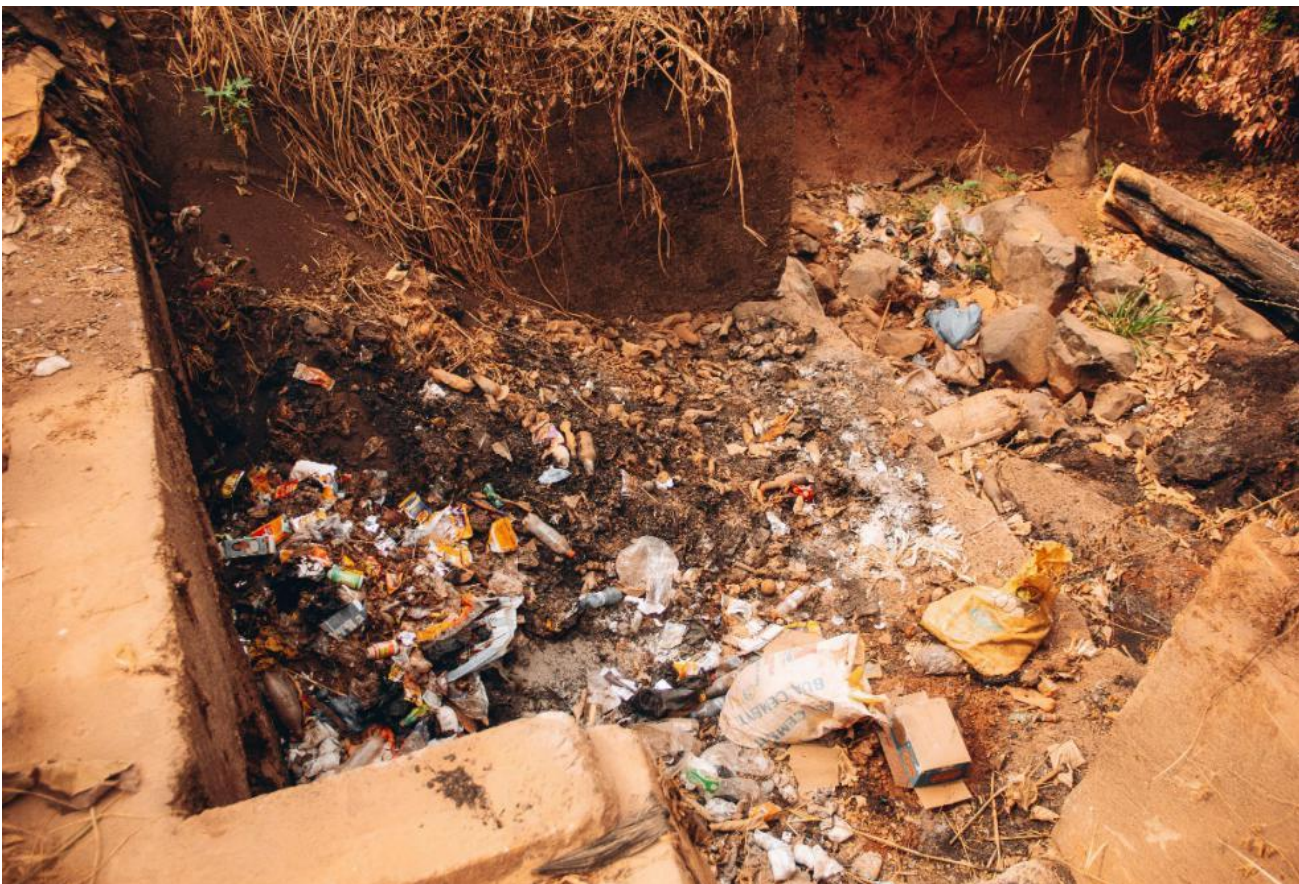
Fig. 6: Gully site at Otolo Nnewi

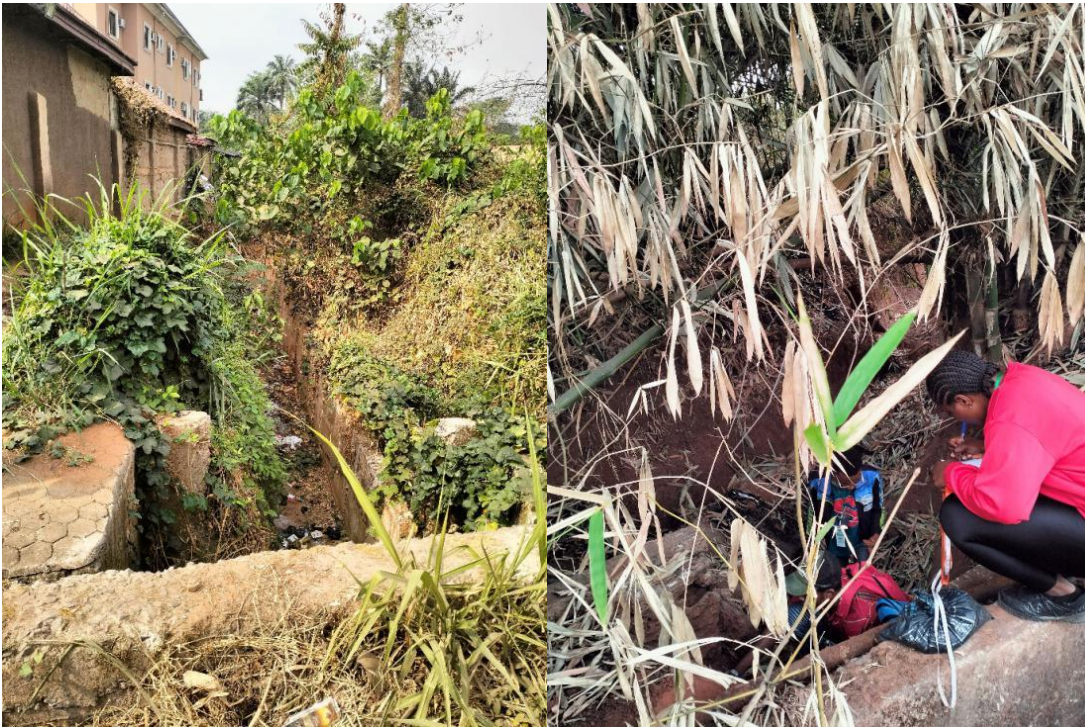
Fig. 7: Gully sites at Utuh

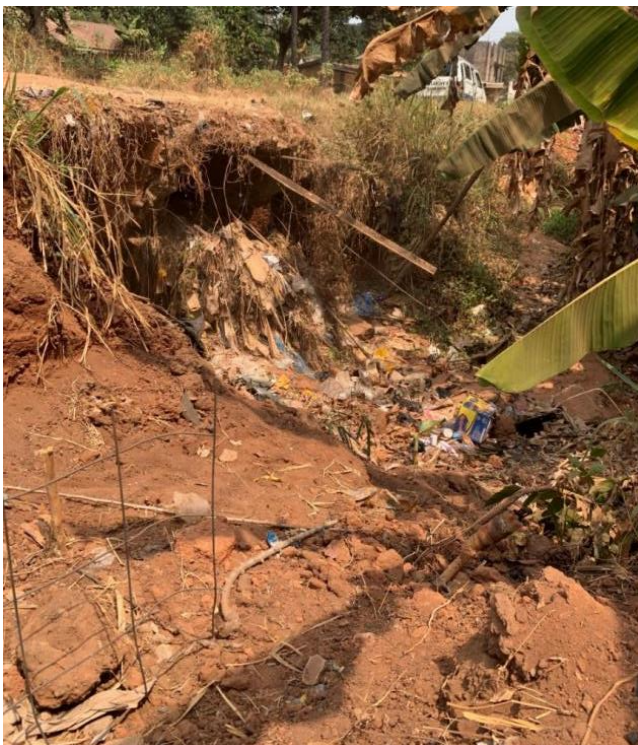
Fig. 8: Gully Site at Ebenator 1

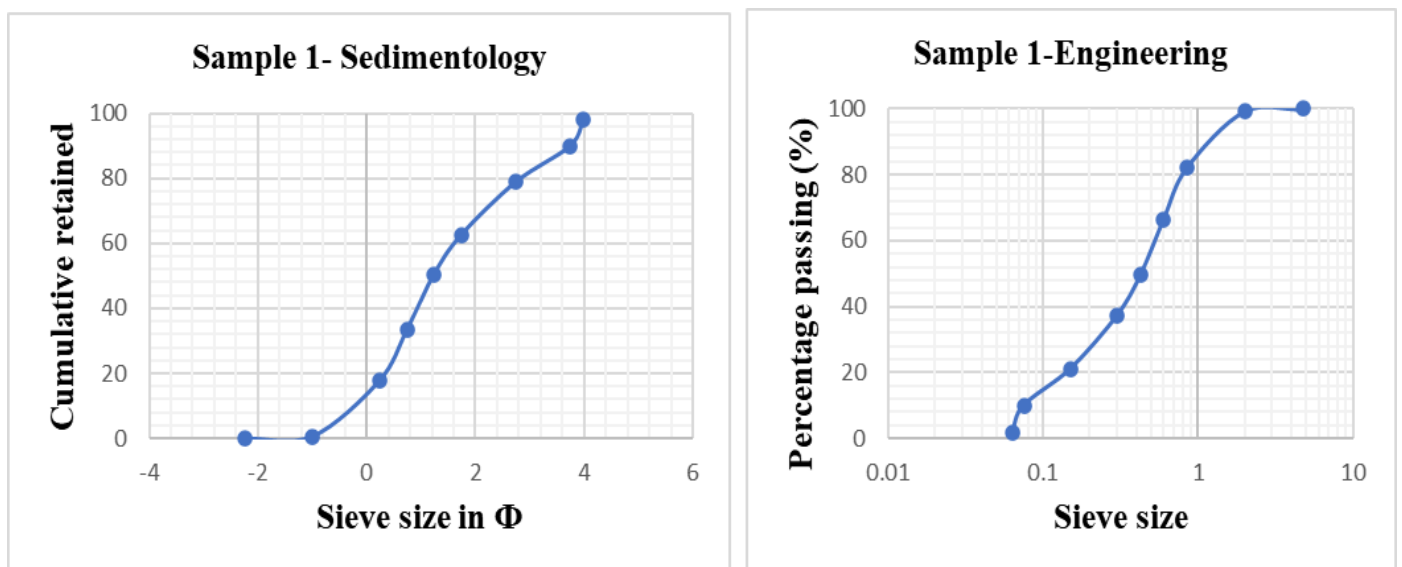
Fig. 10: Showing the sedimentological and engineering PSD curve for Sample 1.

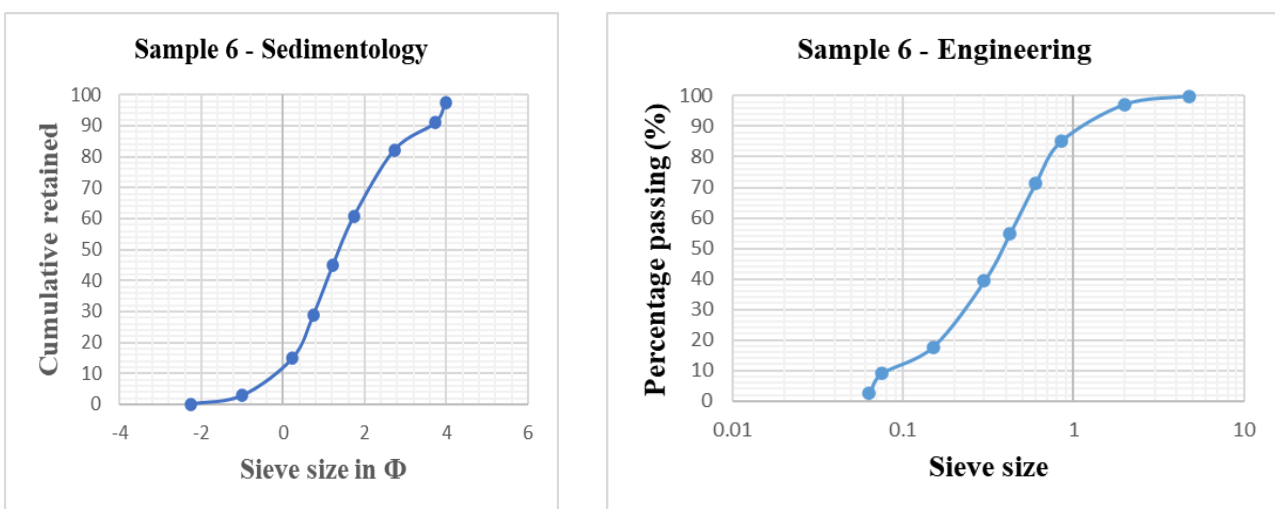
Fig. 13: Showing the sedimentological and engineering PSD curve for Sample 6 at the Otolu Nnewi Gully Site.

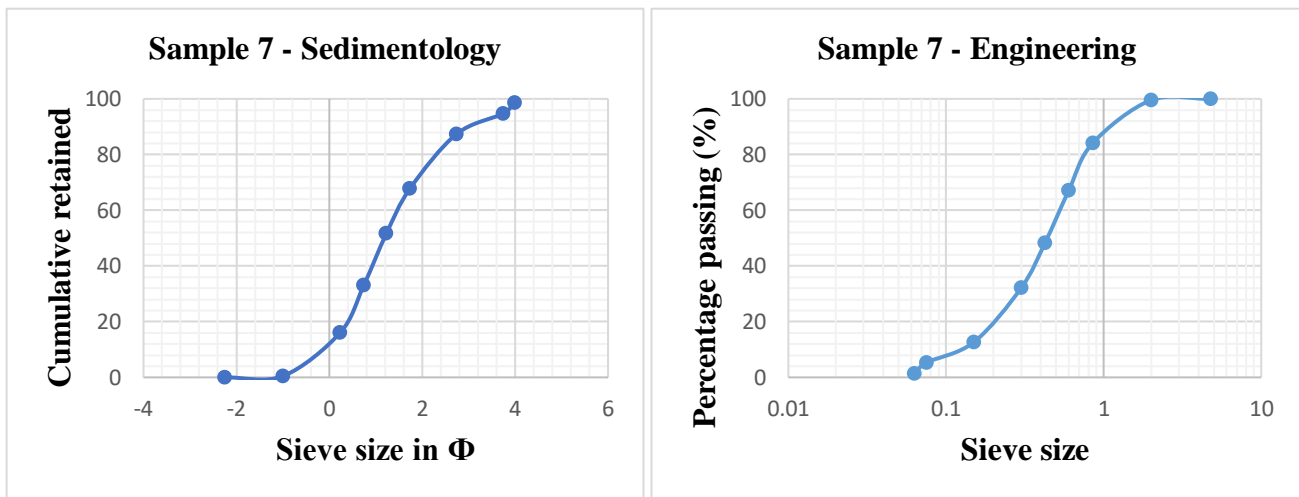
Fig. 14: Showing the sedimentological and engineering PSD curve for Sample 7 at the Utuh Gully Site.

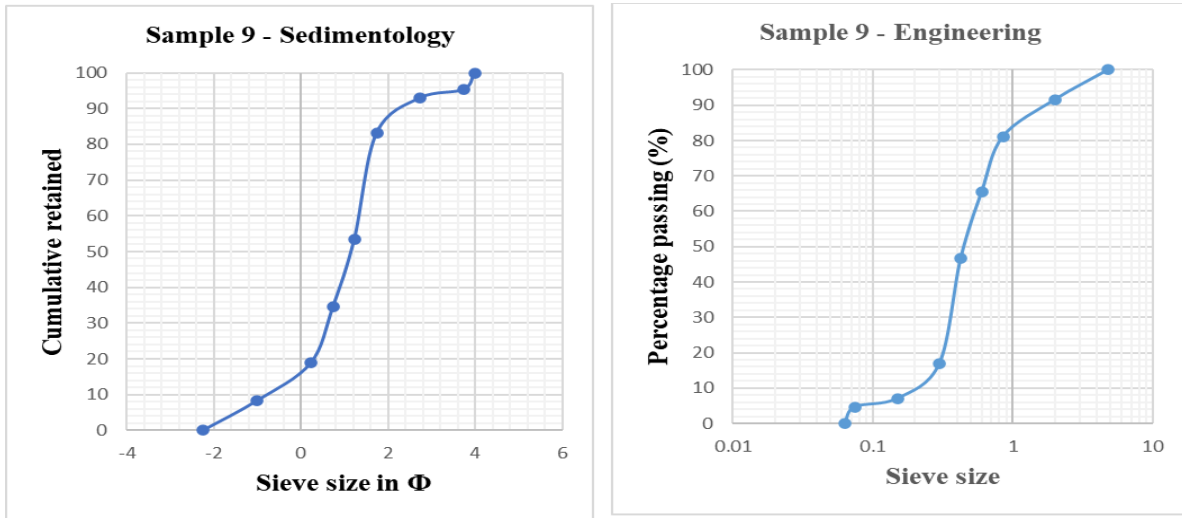
Fig. 15: Showing the sedimentological and engineering PSD curve for Sample 9 at the Ebenator Gully Site.

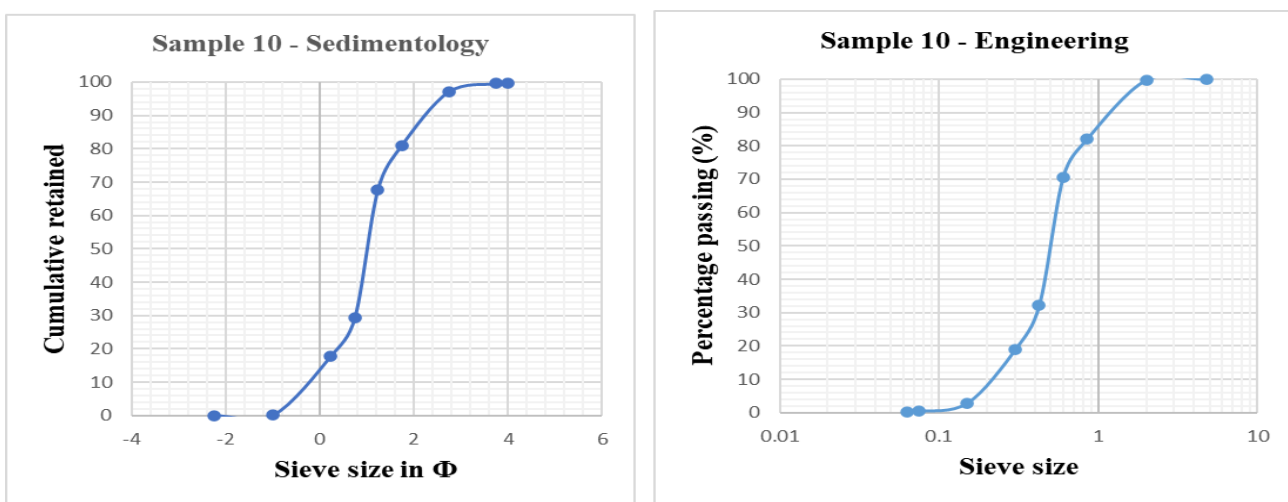
Fig. 16: Showing the sedimentological and engineering PSD curve for Sample 10 at the Ezinifite Road, Ebenator Gully Site.

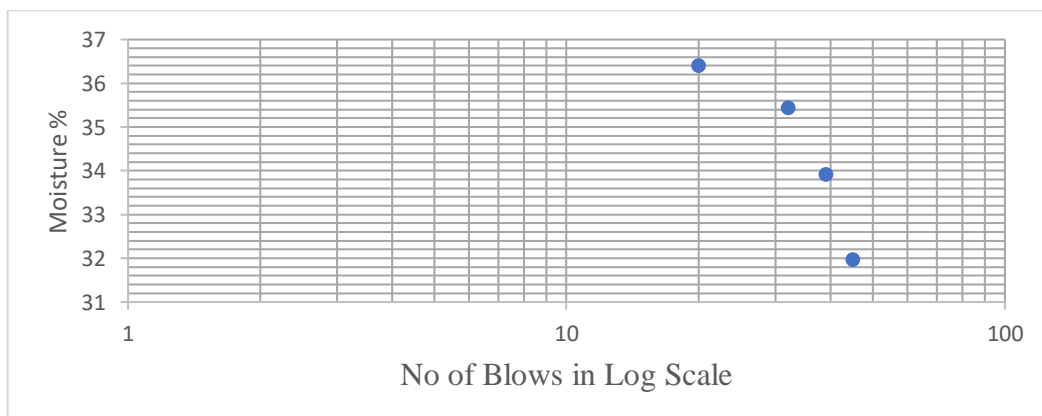
Fig. 17: Liquid limit flow curve for Sample 1 at Ugwu Power, Umunuko-Ukpor

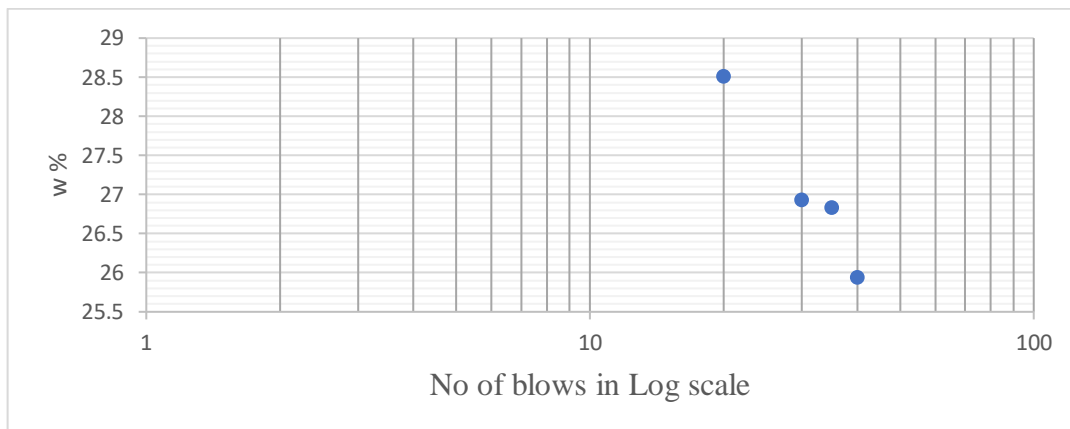
Fig. 19: Liquid limit flow curve for sample 4 at the Otolo Nnewi Gully Site

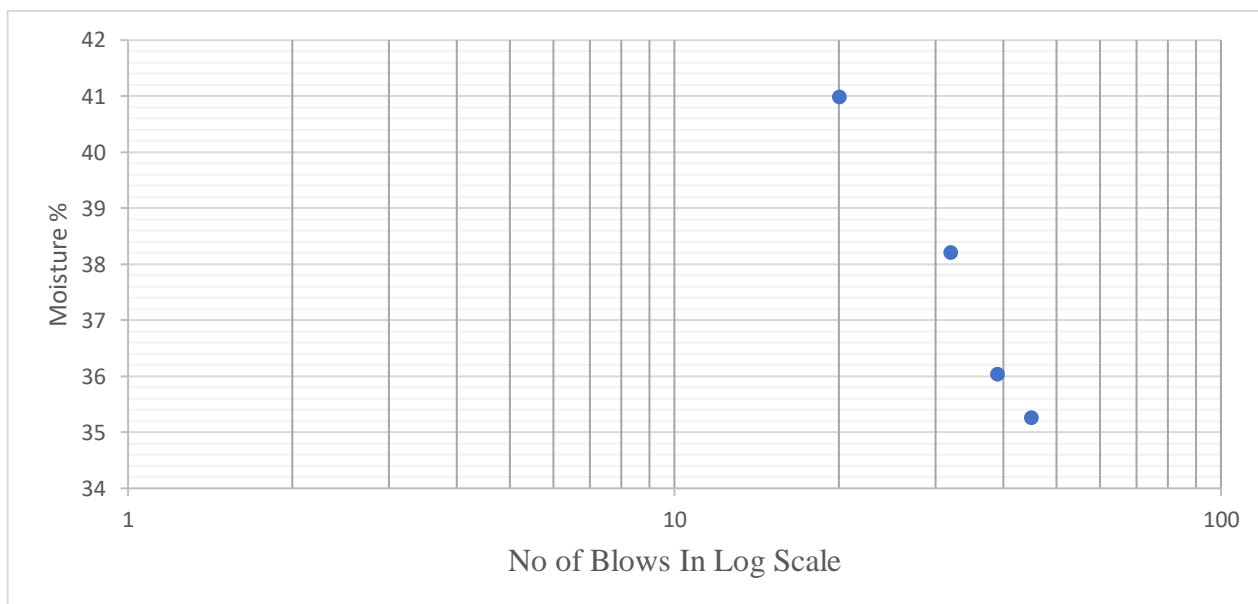
Fig. 20: Liquid limit flow curve for Sample 5 at the Utuh Gully Site

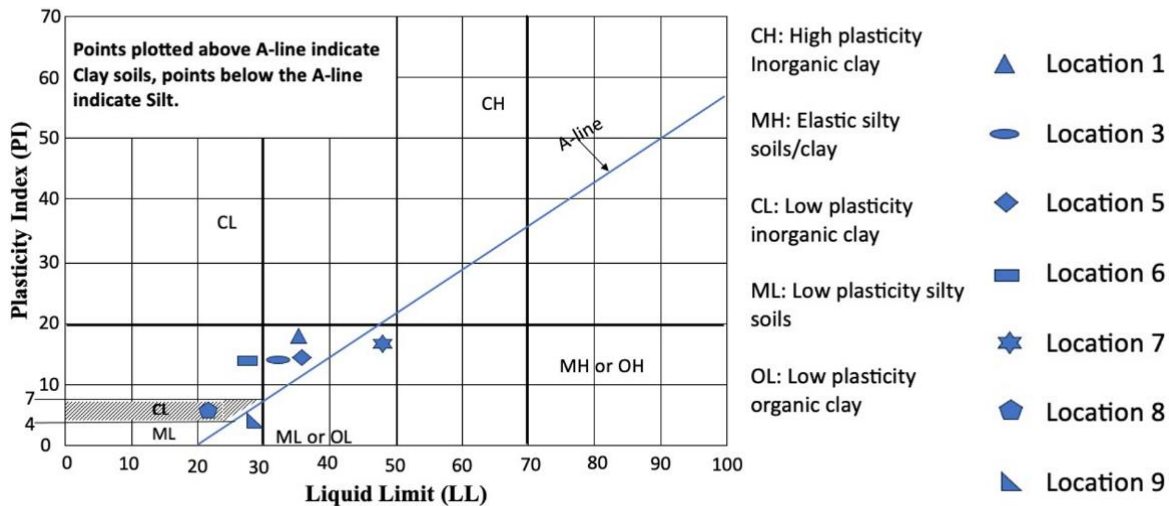
Fig. 21: The classification of the clays in the study area is shown using the USCS plasticity chart.

From the classification above, the study area exhibits a range of clay types, including low plasticity inorganic clays and low elasticity silty soil. Clay samples from Locations 1, 3, 5, 6, and 7 consistently fell above the “A-line” indicating the presence of clayey soils with low plasticity. In contrast, clay samples from Locations 8 and 9 fell below the “A-line” indicating silty soils with low elasticity.
