# Performance Evaluation of the Erer Irrigation Scheme: A Case Study of the Irsha Limat Irrigation Project, Somali Region, Ethiopia

\*Abdijabar Sheik Abdulahi

Department of Water Resources and Irrigation Engineering, Jigjiga University, Jigjiga, Ethiopia

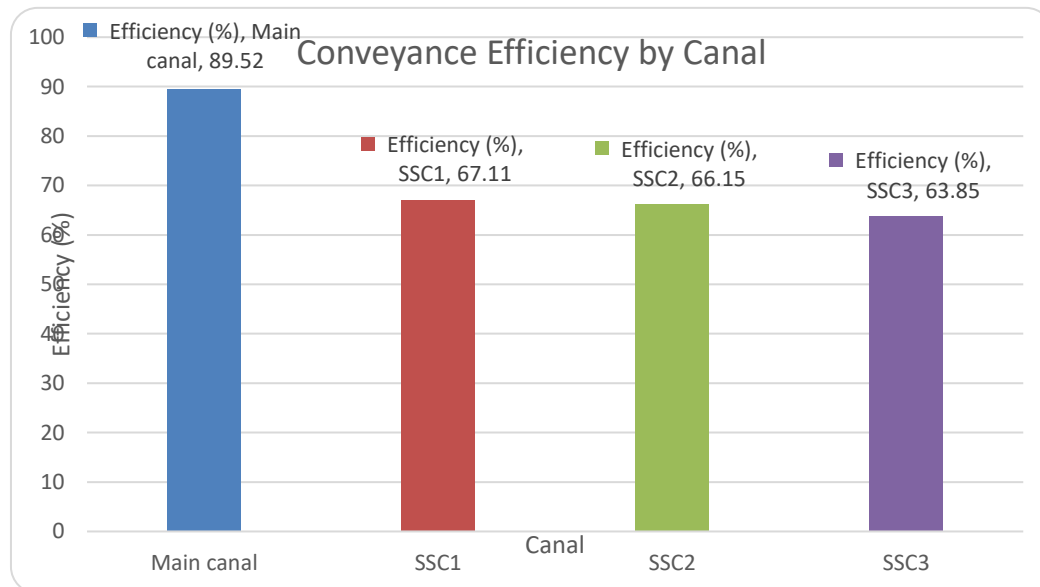
The main canal conveyance efficiency ranged from 85.71% to 93.33%, with an average of 89.52%. Conveyance losses at the monitored 200-m reaches were generally 0.01–0.02 m<sup>3</sup>/s, with an average of approximately 0.015 m<sup>3</sup>/s at the head and middle reaches and approximately 0.01 m<sup>3</sup>/s at the tail reach.

The substantially lower mean efficiencies in the secondary canals indicate greater losses and/or operational variability after water leaves the main canal. The original observations attributed these losses to seepage, cracks, sediment accumulation, and vegetation growth. Because the field record does not provide a quantified contribution for each mechanism, these factors should be interpreted as observed or reported causes rather than separately estimated losses.

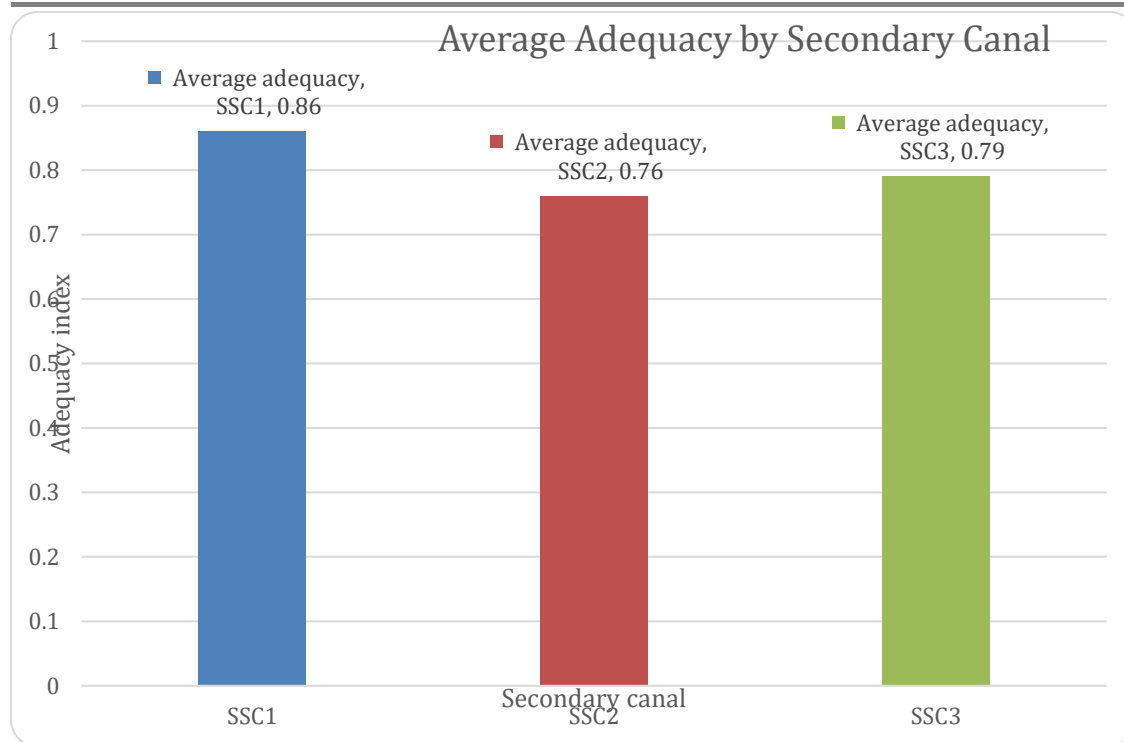
Mean adequacy values were 0.86 for secondary canal one, 0.76 for secondary canal two, and 0.79 for secondary canal three. Using the classification reported in the manuscript (good = 0.90–1.00; fair = 0.80–0.89; poor <0.80), secondary canal one was fair, while secondary canals two and three were poor on the basis of their overall means.

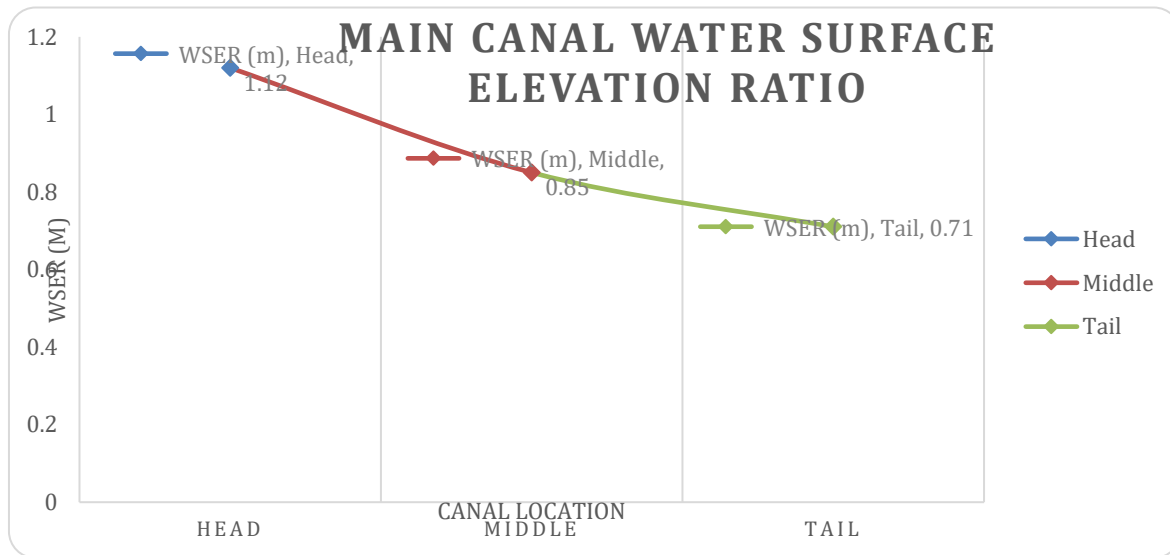
The water surface elevation ratio (WSER) values reported for the main canal were 1.12 at the head, 0.85 at the middle, and 0.71 at the tail. The original manuscript interpreted the lower middle and tail values as evidence of sedimentation and vegetation problems and the head value as indicating possible scouring. These observations are consistent with the field description, although the study does not provide a separate quantified sediment-volume measurement.

1. Rehabilitate non-functional control structures and prioritize the 10 structures that were reported as non-operational.
2. Implement routine desilting and vegetation control, with particular attention to middle and tail reaches where lower water-surface ratios and delivery problems were reported.

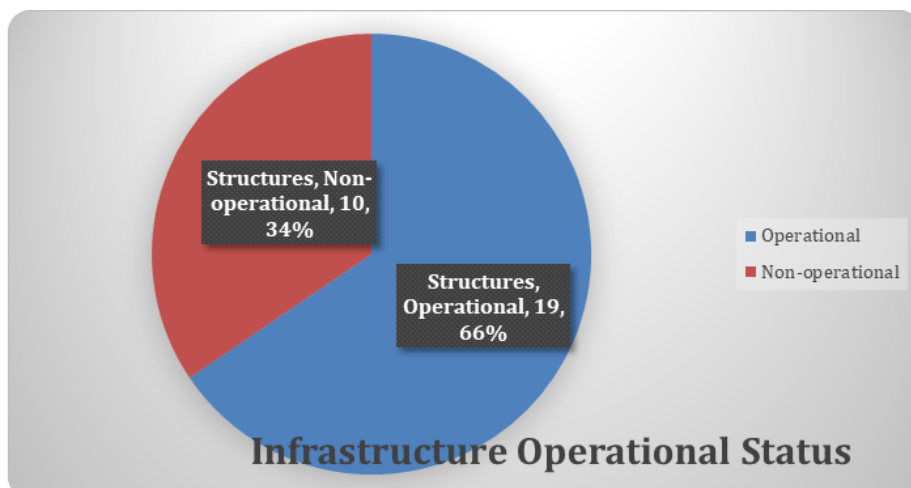
Of the 29 structures originally installed in the scheme, 19 were reported as functional. Infrastructure effectiveness was therefore 65.5% ( $19/29 \times 100$ ). This result indicates that approximately one-third of the originally installed structures were not operational at the time of assessment and highlights a substantial maintenance requirement.

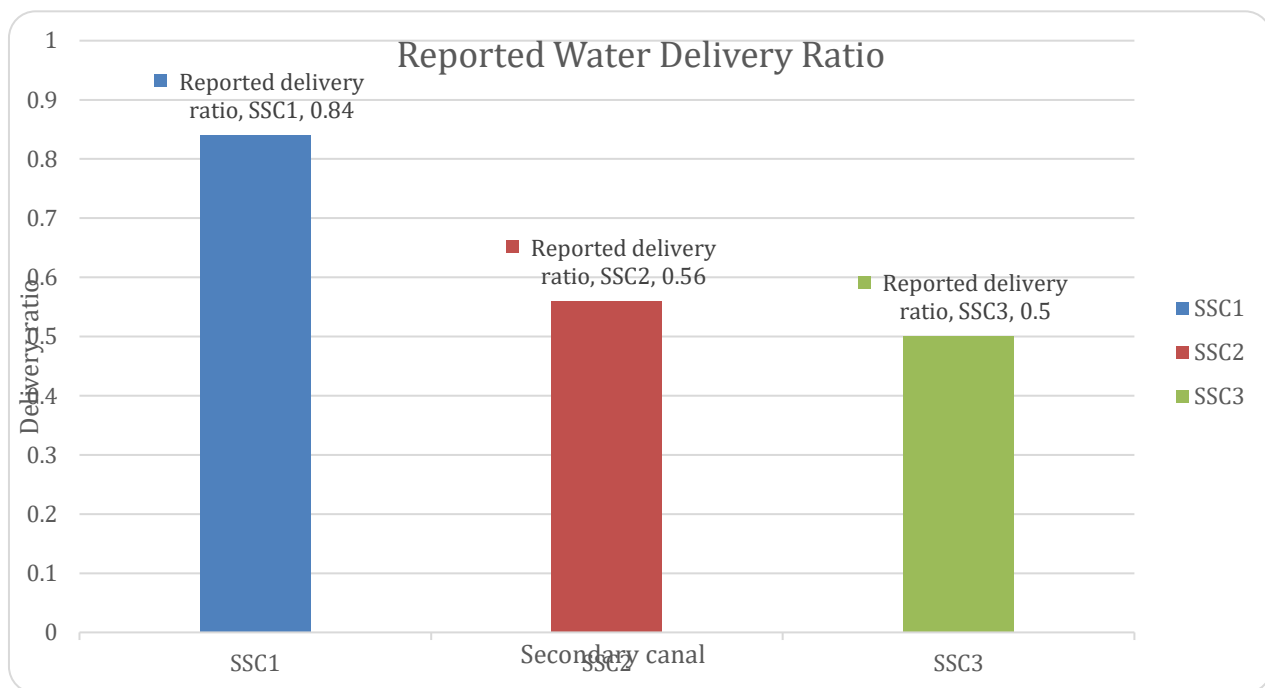
The water delivery ratio, defined as actual discharge divided by design or intended discharge, ranged from 0.56 to 0.84 at the monitored secondary-canal offtakes. The manuscript reported approximate losses of 20%, 10%, and 50% relative to design discharge for SSC1, SSC2, and SSC3, respectively. These values indicate that actual delivery was below intended delivery at all three monitored locations.

The reported maintenance constraints include inadequate maintenance, sediment accumulation, vegetation growth, and structural deterioration. These findings support targeted rehabilitation and routine maintenance of canal sections and control structures.
