Recurrent Flood-Washed Flexible Pavement Failures in Wilberforce Island, Nigeria: Proposed Solutions

Isaac Oludayo Adedokun^{1*}, Ifeolu K. Adewumi²

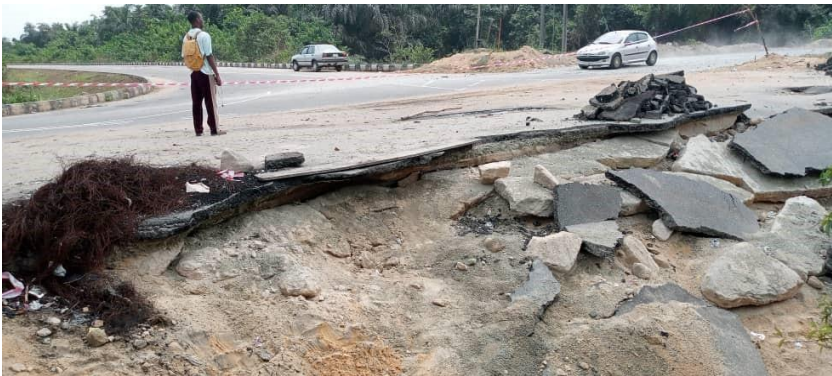
Plate 1: The eroded flexible pavement at the junction to the Cargo Airport along Amassoma Road (¹Adedokun, 2022)

The sand-filled base course method used in the road construction is more or less a levee and locations of the failures are all in stream bed flow with the pavement almost perpendicular to the direction of flow. This the pavement is technically serving as a small earth embankment dam or levee that retains the flood water. With

neither culvert nor French drain to channel the flood water to the other side of river course, the slope of the pavement was too thin to create enough head to resist the hydrostatic pressure of the accumulated water in the upstream side. This was responsible for the piping erosion that leads to the washing away of the sand used in paving the highway. The erosion was easy because there was no impervious core within the section of the highway.

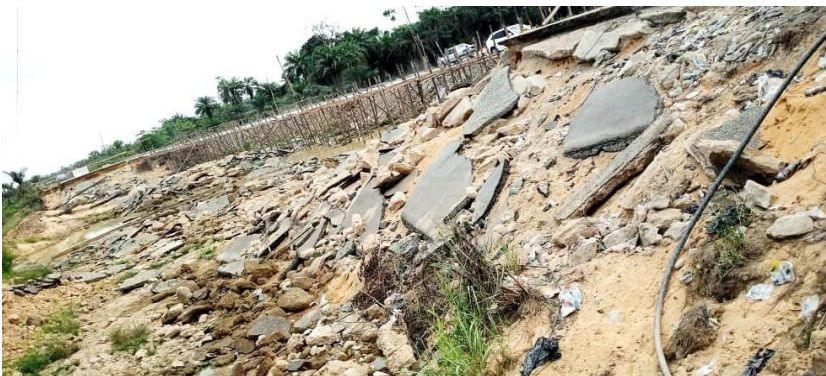
Plate 2: Footbridge constructed over the washed-off pavement to link Tombia community with Amassoma Road (Adedokun, 2022)

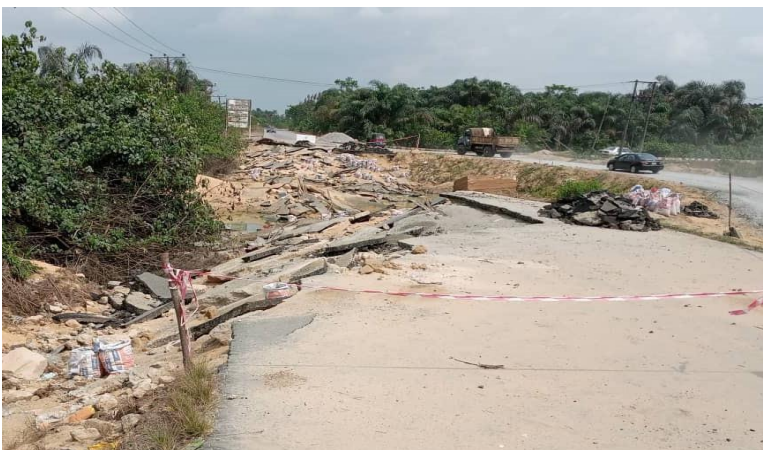
Plate 3: Reconstruction of the failed pavement along Ogobiri - Amassoma Way (Adedokun, 2022)

2. The modification of the pavement design around the frequently breached locations. The method of construction in riverine area, close to the ocean is to use dredged sand as both subgrade and subbase course beneath the riding surface of flexible pavement made with asphalt. However, the highway which is naturally raised above the surrounding terrain has become more or less a levee or small dam. The breached areas are more or less putting hydrostatic pressure on the walls of the highway. Since the slope at those locations and generally along the highway is steep, less than 1:2, it is better to increase the slope to 1:3 with riprap placed on the inner side which now serves as an upstream surface to the highway. This should then be backed with an appropriate size and length of culvert connecting the flood water to the downstream side. Within the upstream side which now serves as a Reservoir, appropriate locations where surface recharge of aquifers could be made should be drilled but have the upper part near the surface widened to contain sand filter medium and adsorption beds to reduce pollution of the aquifer water from washed organic and other hazardous impurities. From our previous studies, a minimum depth of 1.0 m of sand bed and 0.6 m of granular activated carbon bed would remove both filterable and non- filterable solids including some ubiquitous heavy metals such as lead (Pb), arsenic (As) Cadmium (Cd) in particular (Adewumi, 1999, 2006, Adewumi and Ogedengbe, 2006).

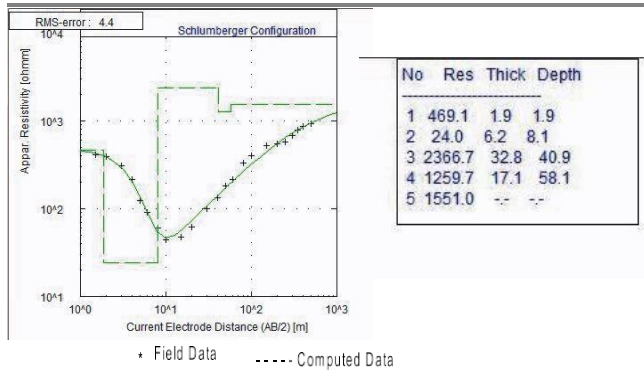
Fig. 2b: Geo-electric layers for VES 2

The summary of the lithology obtained and the geo-electric layers for each of the VES stations in the study area are shown in Fig (1a – 5a) and Fig. (1b - 5b) respectively. The apparent resistivity curve types obtained are QHA for VES1, QH for VES (4 and 5), HKA for VES 2 and KHA for VES 3. Each layer in all the stations (VES 1 – VES 5) was considered together with a view to following the trend, in all, from the topsoil to the depth where the effect of the flood-washed stopped. This gave the information about the affected depth, from the surface, to which necessary solutions must be applied. In all the locations where the geophysical survey was conducted, the topsoil, which was mainly silt and unconsolidated materials has highest resistivity than the subsoil except in VES 3.

Each of the layers is presented as (observed resistivity, thickness and depth): For the first layer; VES 1 (327.2Ωm, 1.9m, 1.9m), VES 2 (469.1 Ωm, 1.9m, 1.9m), VES 3 (49.9 Ωm, 0.8 m, 0.8 m), VES 4 (155.7 Ωm, 1.6m, 1.6 m) and VES 5 (244.0 Ωm, 1.7m, 1.7m). This wet topsoil has a depth ranging from 0.8m to 1.9m and resistivity values between 47.1 Ωm and 469.1 Ωm. The subsoil, generally of lower resistivity, can be considered as fine Clay of varying resistivity values from 24.0 Ωm to 189.8 Ωm at depths between 4.0m – 8.1m. This second layer has for VES 1 (122 Ωm, 2.8m, 4.6m), VES 2 (24.0Ωm, 6.2 m thick and extending to 8.1m below the surface), VES 3 (154.2Ωm, 3.8m, 4.6m). VES 4 (37.4 Ωm, 4.1m, 5.7 m). and VES 5(189.8Ωm, 2.3m, 4.0m) , This layer could be generally fine sandy Clay.

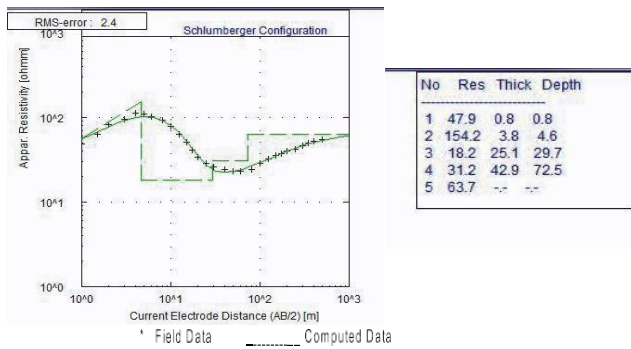
Fig. 3b: Geo-electric layers, for VES 3

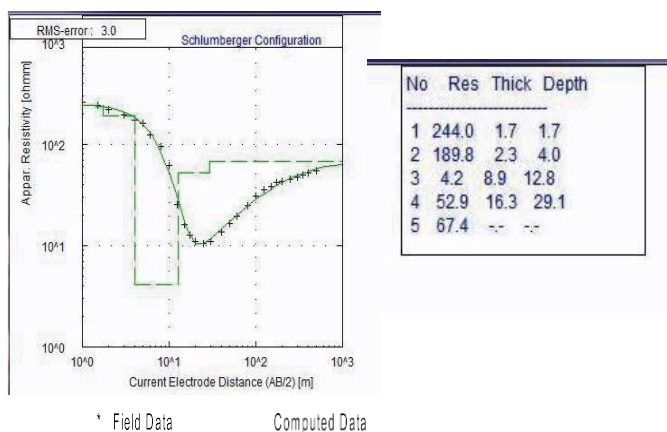
Fig. 5b: Geo-electric layers for VES 5
