# Forensic Evaluation and Condition-Based Rehabilitation of A High-Rainfall Mountain Highway: Samdrup Jongkhar–Trashigang Road, Bhutan

Deepak Baskandi

Border Roads Organisation

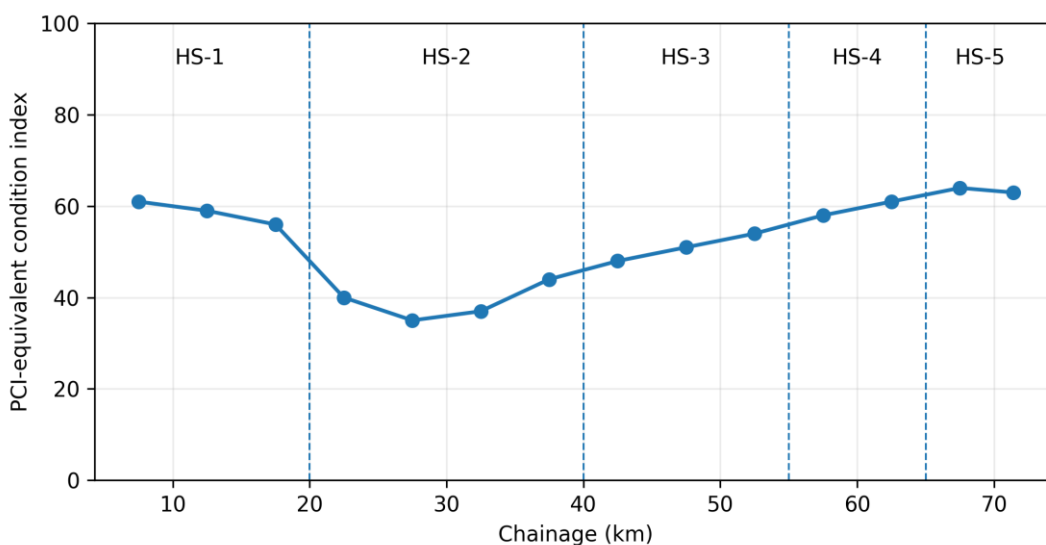
Fig. 4. PCI-equivalent profile and preliminary homogeneous performance sections.

Five preliminary homogeneous sections result: HS-1, Km 5-20; HS-2, Km 20-40; HS-3, Km 40-55; HS-4, Km 55-65; and HS-5, Km 65-72.8. The boundaries coincide with changes in distress morphology, pavement history, and age. They remain preliminary until verified against corrected FWD bowl parameters, actual layer thickness, traffic, and subgrade data. This distinction is important: PCI describes surface condition but does not directly measure structural capacity, roughness, or skid resistance (ASTM 2024).

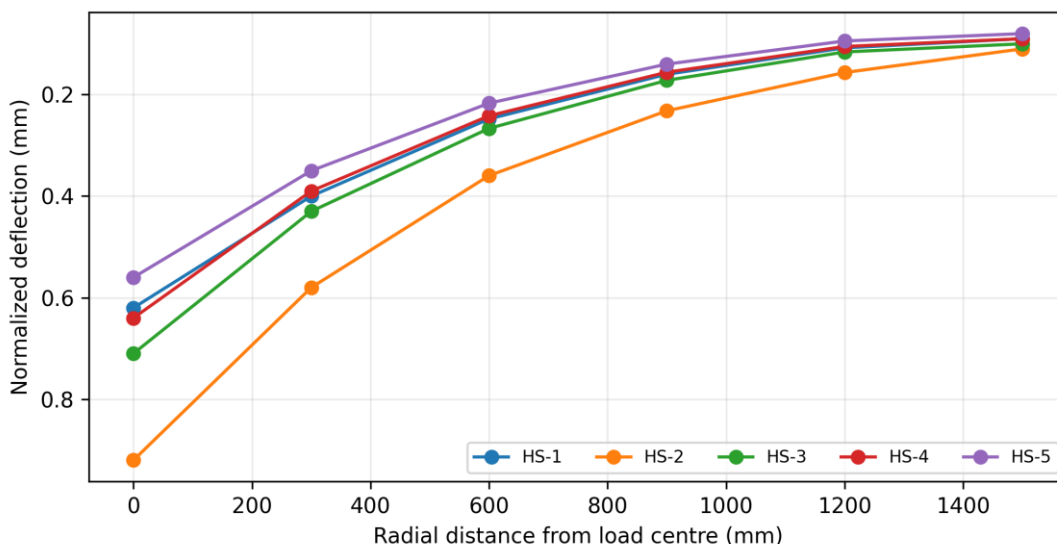
Fig. 5. Normalized FWD bowls illustrating section-specific structural response.

Core/material indicators tell a different but complementary story. HS-3 has the lowest recorded interlayer bond range (0.35-0.55 MPa) despite only moderate FWD response, matching the observed concentration of slippage. HS-2 combines relatively high air voids, visible stripping, low bond, and adverse structural response. HS-5 has the best density and bond range, so recurrent distress there would more strongly imply localized construction variability, braking geometry, or unobserved moisture paths. Literature shows that field-core bond testing is preferable for forensic work because it captures the combined effects of surface preparation, tack application, compaction, contamination, and construction variability (Doyle et al. 2022; Haslett et al. 2023).

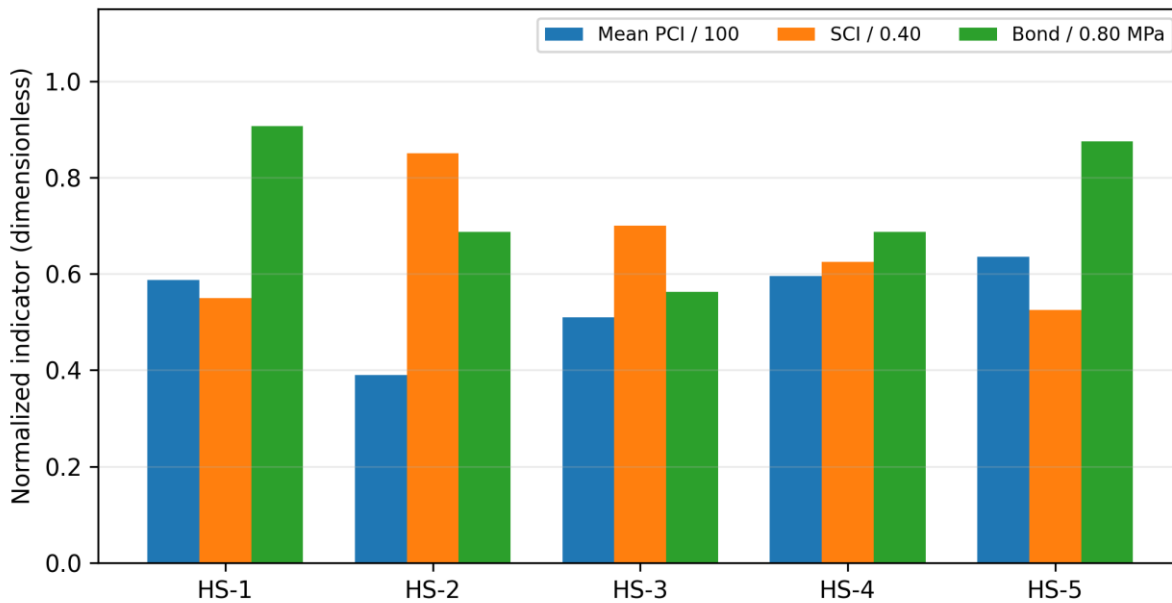
Fig. 6. Normalized comparison of surface condition, SCI, and midpoint interlayer-bond indicators by homogeneous section.

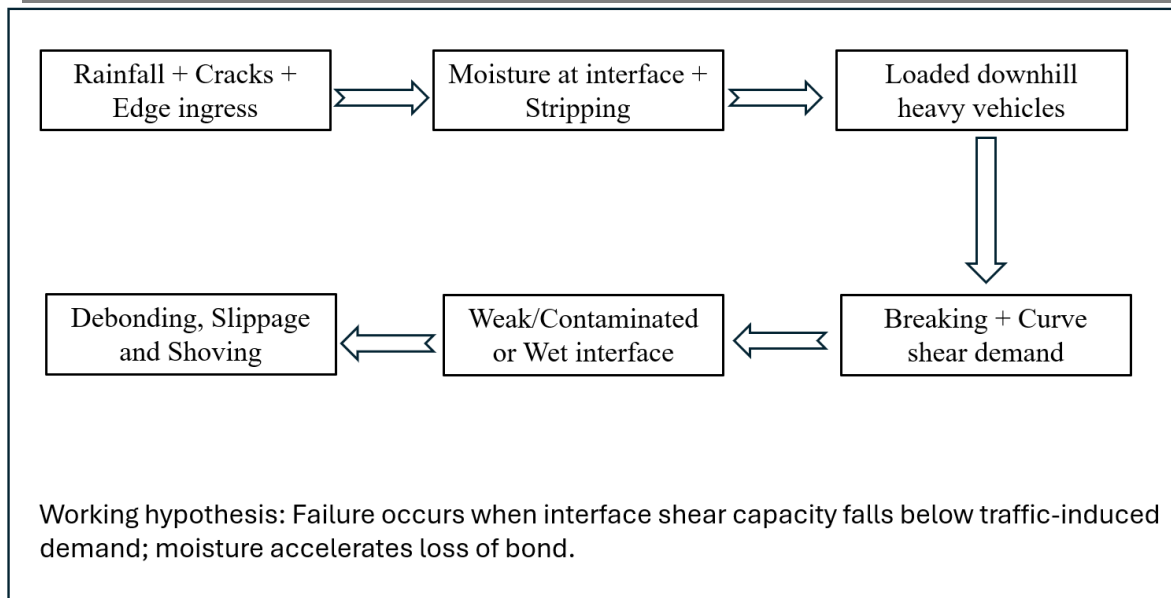
The integrated evidence supports a working mechanism in which loaded downhill trucks generate elevated longitudinal and tangential stresses at curves and braking zones. If tack coat is inadequate, the receiving surface is dusty or wet, or moisture has degraded the interface, available shear capacity is reduced. Repeated loading then produces relative movement of the upper course, followed by crescent cracking, shoving, local delamination, and breakup. Rainfall and fog accelerate deterioration by sustaining wet conditions and transporting water through cracks and edges toward the interface. The mechanism is consistent with published evidence that slippage is associated with high horizontal force zones and that interlayer performance depends on surface condition, tack application, temperature, and moisture (Mohammad et al. 2011; Al-Qadi et al. 2023).

Fig. 7. Mechanism-based hypothesis for recurrent downhill slippage.

Tack coat should therefore be treated as a performance-critical interface. IRC:16-2008 specifies tack-coat practice for bonding an existing bituminous surface to a new course. The receiving surface must be clean, uniformly treated, and protected from contamination before paving. Published research also cautions against assuming that “more tack” always produces higher bond: optimum residual rate depends on surface texture, material, and test condition, and excessive binder can itself create a weak plane (Yang and Li 2021; Al-Qadi et al. 2023). Consequently, recurrent sites should be evaluated using field-core bond/shear testing rather than material type or nominal spray rate alone.

For localized slippage, milling or saw-cutting should extend beyond visible distress until sound, stable material is exposed. The lower layer should be examined for stripping, deformation, trapped moisture, and delamination. Only after the substrate is dry or appropriately conditioned and free of loose material should tack coat be uniformly applied with a calibrated distributor. Dense BC is suitable where the defect is shallow; DBM + BC is required where removal extends deeper or structural design indicates strengthening. A routine seal coat over dense BC is not inherently required. Traffic opening should follow cooling, joint finishing, and acceptance checks.
