An Analysis of the Impact of Urbanization on Natural Character of Coastline Along Southern Suburbs of Colombo, Sri Lanka

N. Malalarathne^{1*}, H. K. Nandalal², Y.M.R.N. Samarakoon¹

¹National National Aquatic Resources Research and Development Agency (NARA), Crow Island, Colombo 15, Sri Lanka

²Department of Civil Engineering, University of Peradeniya, Peradeniya, 20400, Sri Lanka

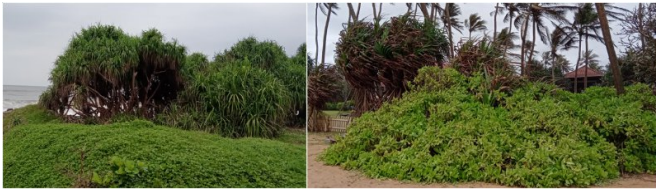
Figure 3.3: Typical natural vegetation along beaches in the study area
