Heritage Expert's Review of the Environmental and Social Impact Assessment Study Report for Proposed Palm Exotja Highrise Resort Project at Dabaso, Kilifi County, Kenya

Philip Mwasame Wanyama

Coastal Archaeology, National Museums of Kenya P.O Box 82412 GPO 80100, Mombasa, Kenya

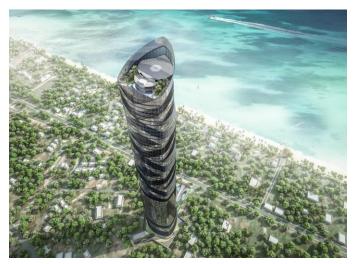
Figure 1. The graphic illustration of the proposed Palm Exotica Highrise Resort facility. Notice the location is at closer proximity to the beach. Source: Njoroge, Karanja & Gathuma, 2019.

The proposed Palm Exotja project will be a mixeduse iconic high-rise resort facility of 61 floors and 380 metres high, probably the tallest building in Kenya. The location of the project site is on the L.R No., Gede/Kirepwe B/369, Turtle Bay Road at Dabaso, Kilifi North, in Kilifi County (see Figure 2). The actual piece of land measures 2.4 acres currently undeveloped and the constructed area will comprise a total of 209026 square metres (see Figure 1). Apart from, the high-rise tower, there will be built a parking and service building of five storeys each, the waste water treatment plant, two boreholes, a helipad and underground water reservoirs, boundary wall, drainage works and other associated facilities. This project area is situated within the Physical Planning Department (Government of Kenya) zonation area set aside for agricultural production activities. The project proponent will require a permit for change of use for the land the site (ibid.:10). It is estimated the proposed Palm Exotja project will cost Kenya Shillings 28,000,000,000.00 (US Dollars 280,000,000.00) and this seems a very huge investment.
