# GLOF Disaster in Sikkim: A Case Study of South Lhonak Lake

Dr. Shabnam Ara

Department of Geography, Hamidia Girls' Degree College, University of Allahabad, Prayagraj

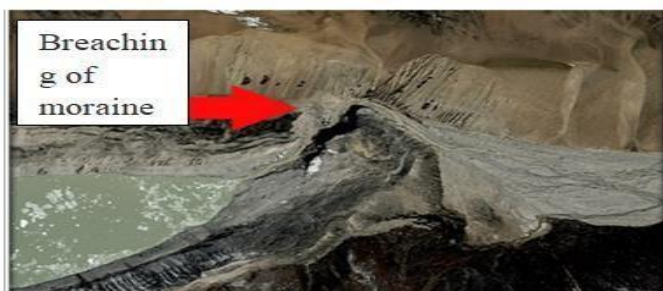
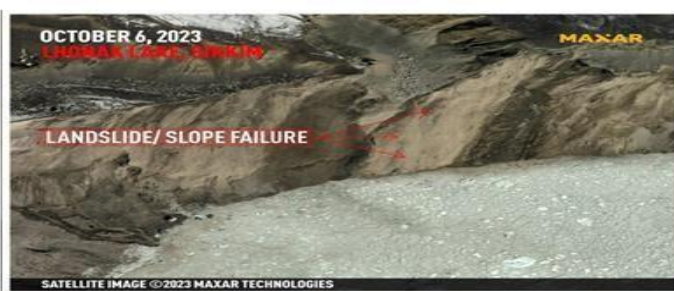
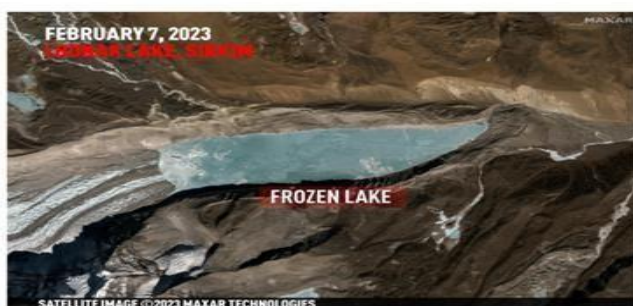
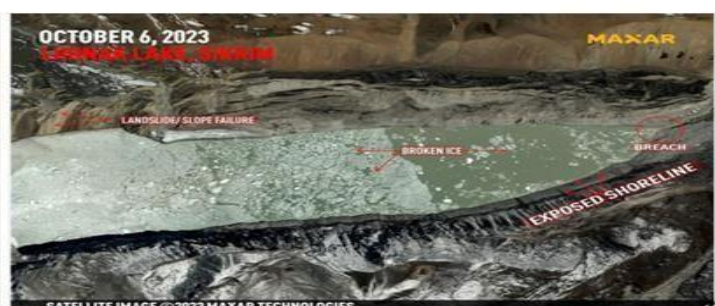
The resulting catastrophic multi-hazard cascade released an unprecedented volume of high-velocity meltwater downstream. The floodwave decimated the Chungthang Hydroelectric Dam within approximately ten minutes and severely impacted over 88,000 people across regional and trans-boundary downstream communities. Post-disaster satellite observations (Figure 5) delineate the exact zone of the structural breach along the moraine dam. The imagery confirms that significant volumes of meltwater continued to discharge from the lake three days post-burst. Consequently, the dramatic reduction in water volume has exposed a substantial portion of the dynamic shoreline that was entirely submerged prior to the event.
